EFFECTS OF GAS ATMOSPHERE AND SURFACE QUALITY ON ROUGING OF THREE STAINLESS STEELS IN WFI

ABSTRACT

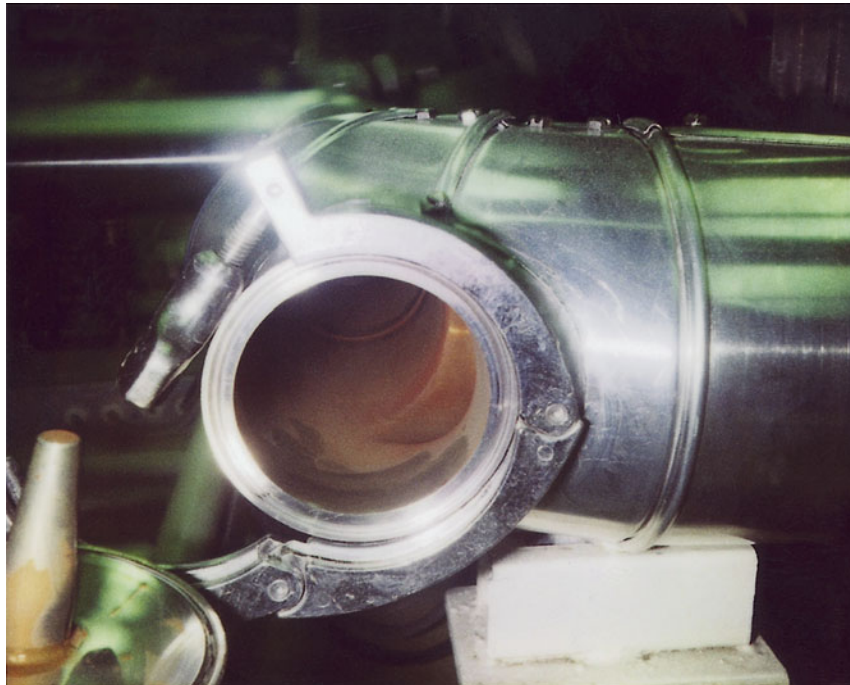
FIGURE 2 - Rouging in a WFI pipe arrangement.

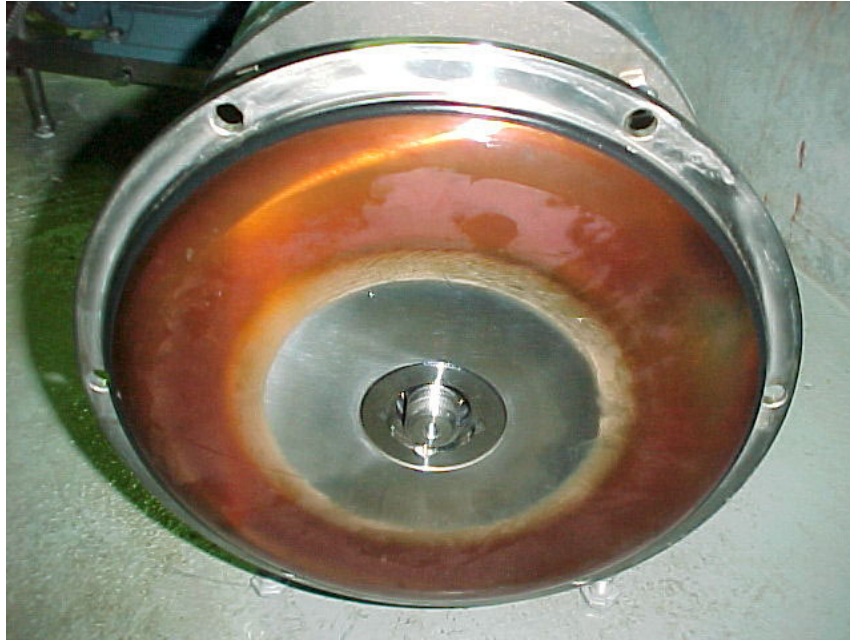
FIGURE 3 - Rouging in a WFI pump.

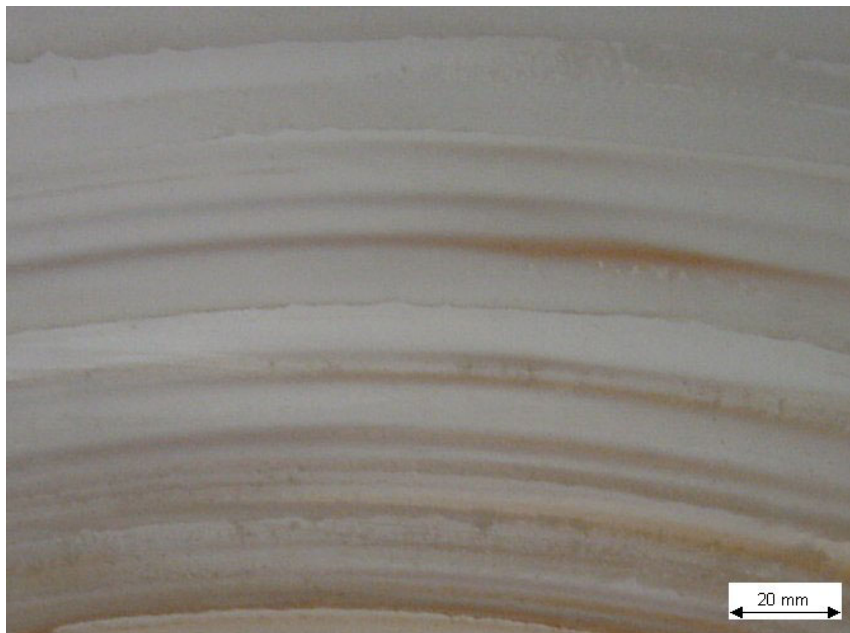
FIGURE 4 – Rouge in a WFI buffer tank. As a result of an alternating water level, rouge has deposited on the shell in circumferential areas of varying height.

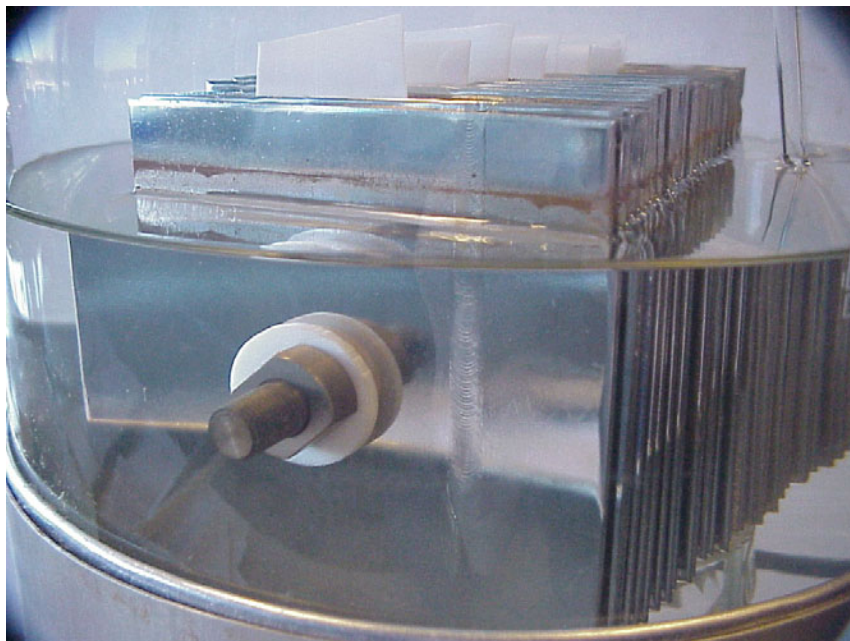
The first signs of rouge became visible after four days of exposure while only little development was observed during the remaining exposure period. In all cases rouge was seen as deposits along the water line of the coupons as shown in Figures 6-7. The most evident rouge formation was seen in the cells purged with N₂ or air with addition of CO₂. The two other atmospheres (air and air minus CO₂) showed less or no rouge formation. This became clear when the coupons and PTFE strips were studied closely after dismantling the cells, see Figure 8. Table 3 summarized the results of the first test series.

FIGURE 6 – Test cell with a coupon rack showing rouge at the water line after 3 weeks exposure in WFI purged with N_2 (boiling was paused). The coupons include both the #80 and the 2B + ep finish of EN 1.4435 material.

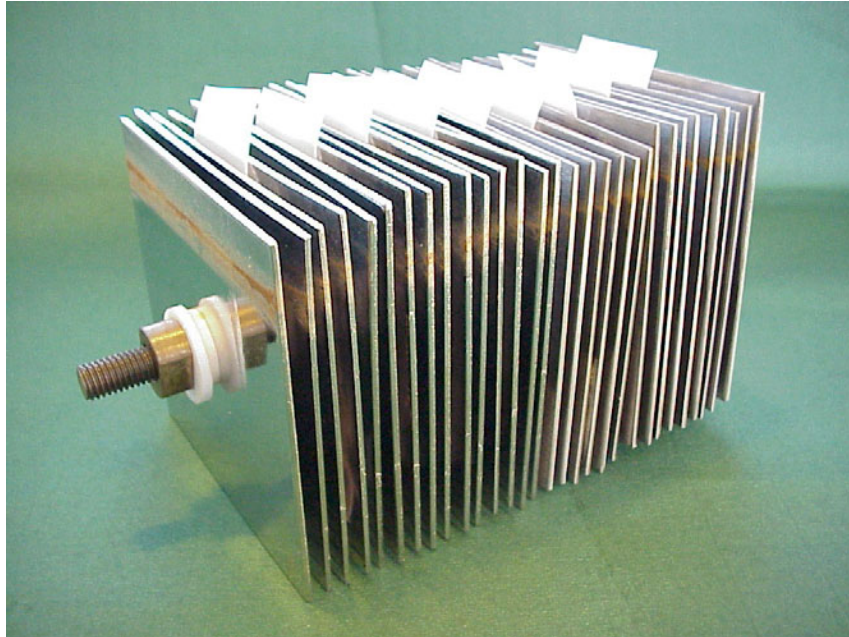
FIGURE 7 – The same coupon rack as shown in Figure 6. The rouge deposits at the water line is very distinct.

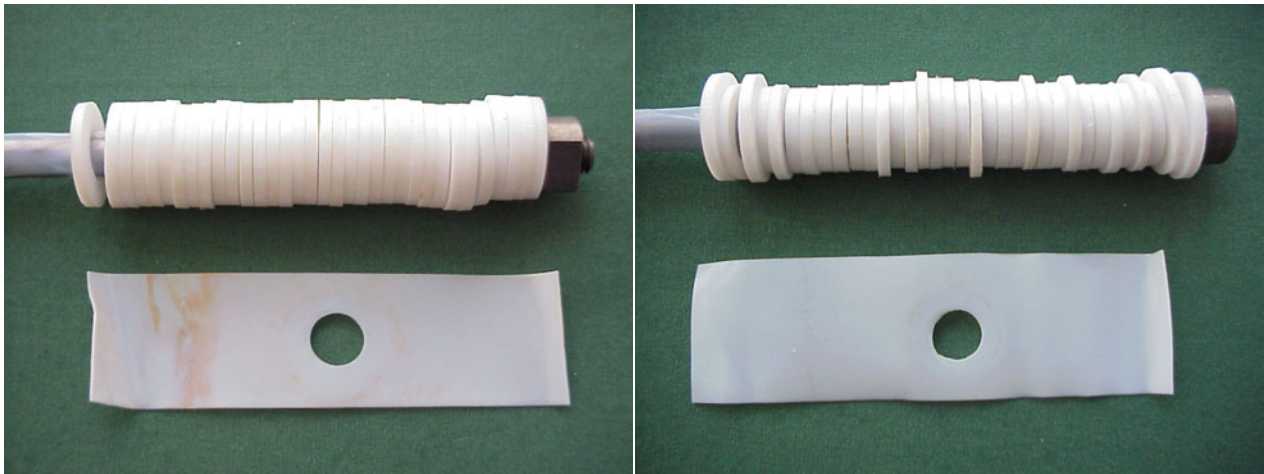
a.
b.
FIGURE 8 - Teflon spacers and strips after exposure of EN 1.4435 in WFI purged with a) air + 1% CO₂ and b) Air minus CO₂.

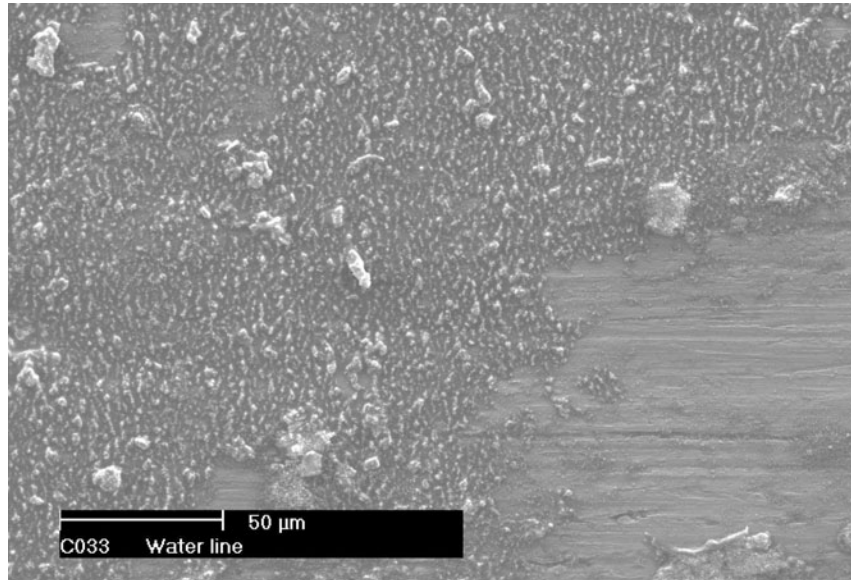
FIGURE 9 – Scanning electron micrograph showing exposed coupon covered by loosely adhered rouge deposits.

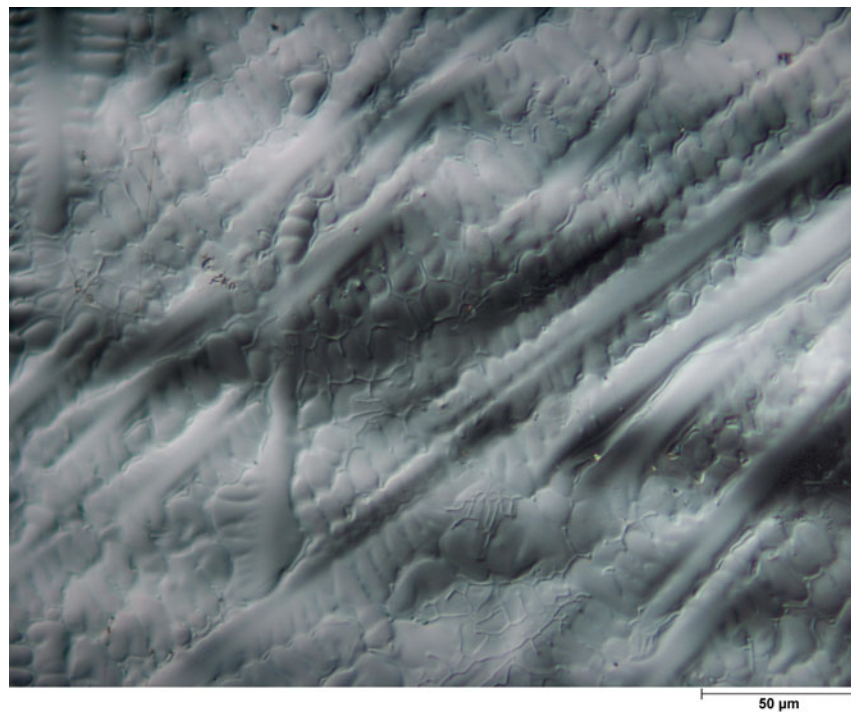
FIGURE 10 - Weld metal of an electropolished EN 1.4435 coupon. The picture was obtained by light microscopy and shows a small amount of δ -ferrite distributed as a skeleton between the primary austenitic phase.
