COMMON CORROSION PROBLEMS IN THE BREWERY SECTOR

Jan Elkjaer Frantsen, Troels Mathiesen
FORCE Technology
Park Alle 345
Corrosion & Metallurgy
Brøndby, 2605
Denmark

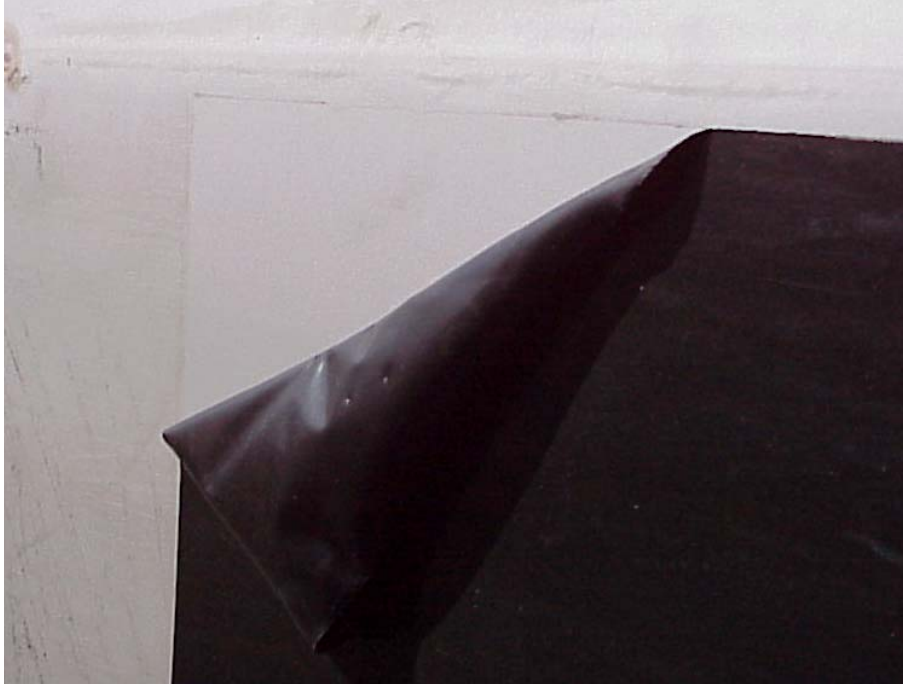
FIGURE 1 – Protective plastic foil on a stainless steel sheet.

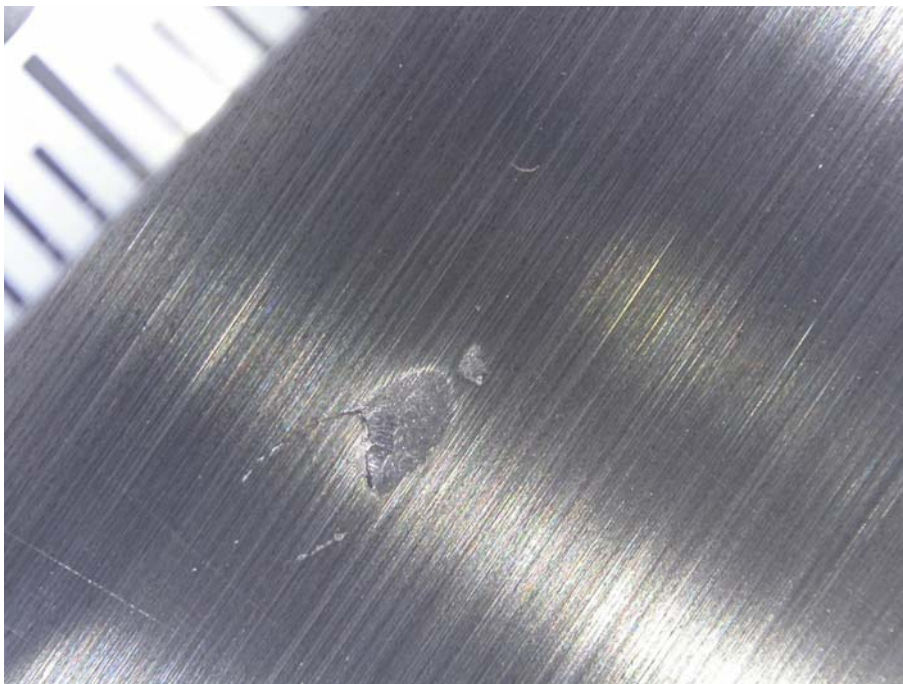
FIGURE 2 – A rolling defect in an AISI 316L sheet. Unfortunately, the pictured rolling defect was just one of many identical defects in the coil from which the tank was made. None of the defects were observed until the protective plastic foil was removed just prior to the completion of the tank.

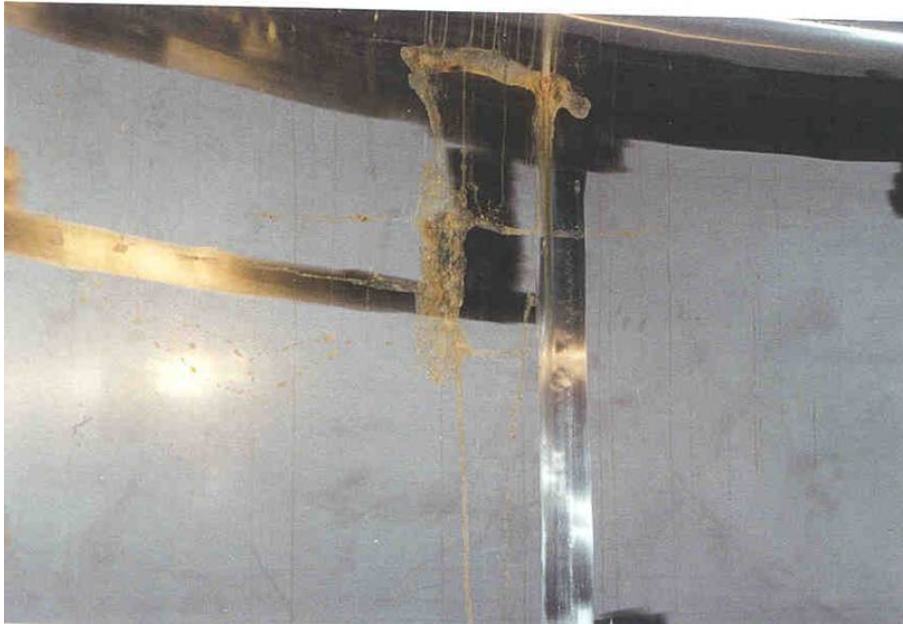
FIGURE 3 – Rust runs with a vast number of pits were present from the top of the AISI 304 bright beer tank and downwards. The distribution of rust runs and pits showed that the tank once in a horizontal position had suffered corrosion due to exposure to a corrosive fluid (which later turned out to be seawater).

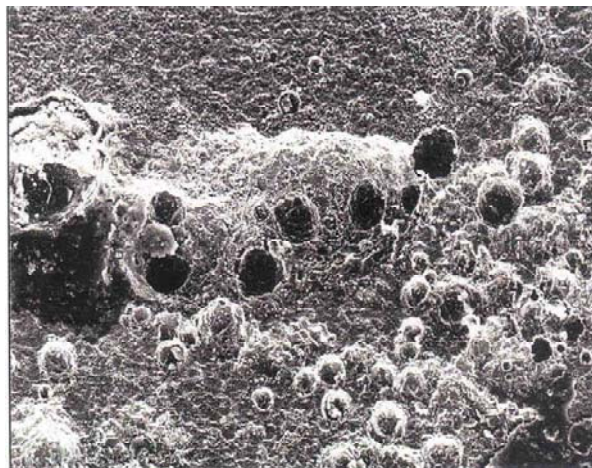
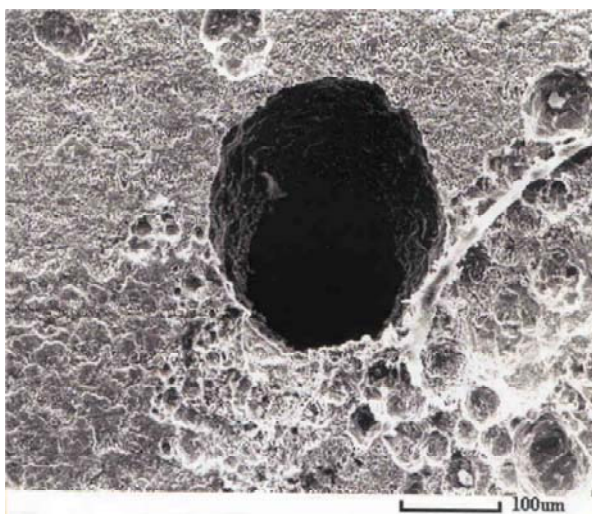
FIGURE 4 – A sample was cut out of the tank (figure 3) for closer investigation in the laboratory. The SEM photos show examples of the pits.

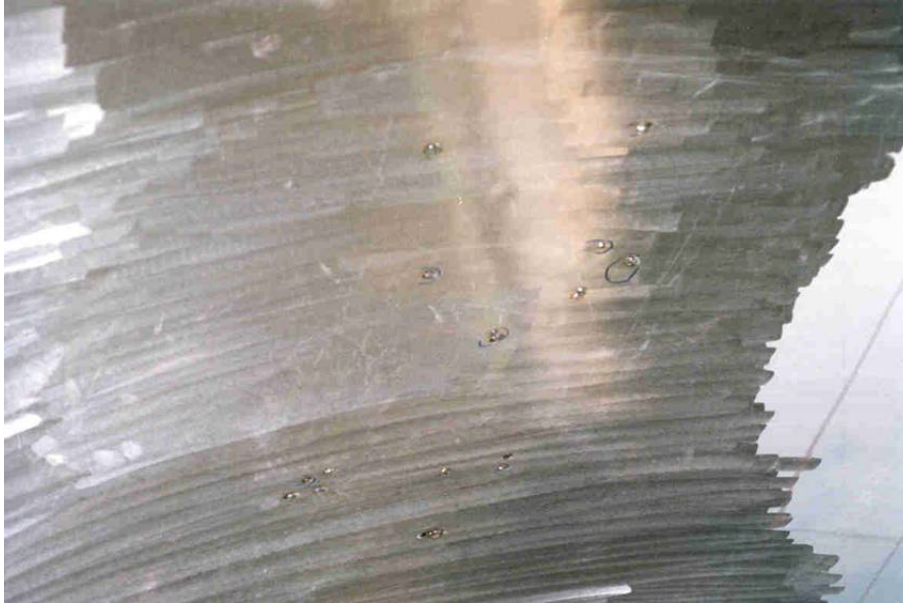
FIGURE 5 – Many pits were so deep that they could not be removed completely by grinding without thinning the material below the minimum required wall thickness. Consequently it was necessary to perform repair welding.

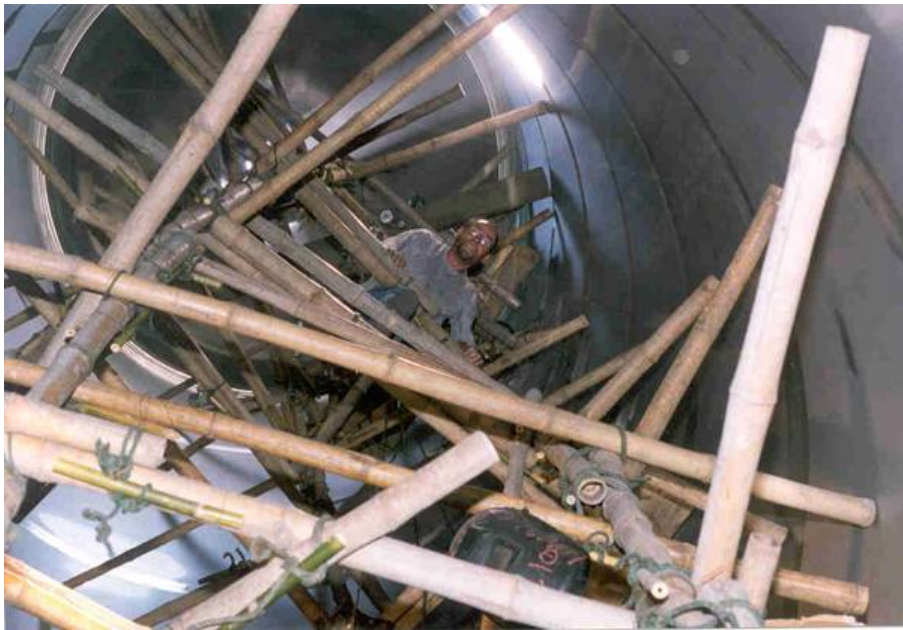
FIGURE 6 – Overview photo showing the magnitude of the repair work.

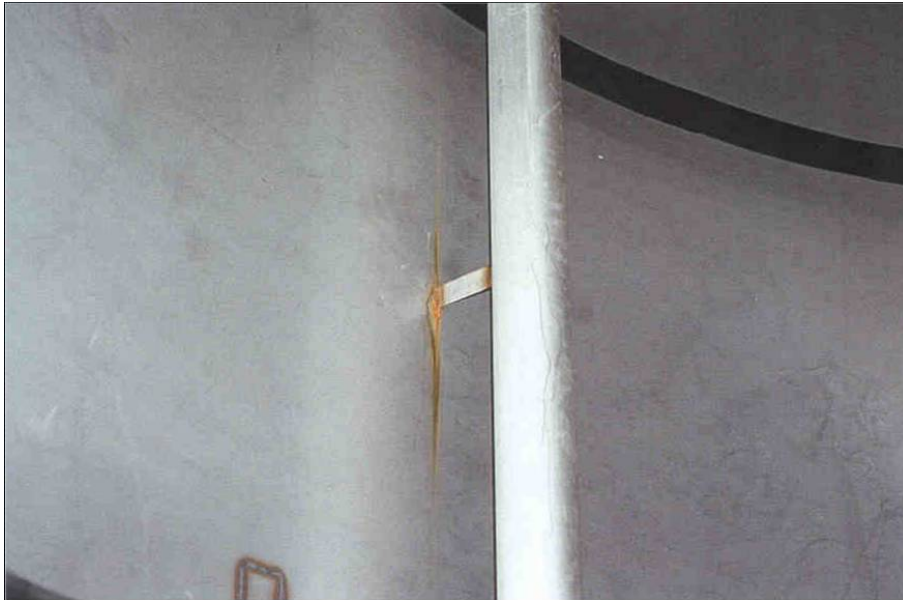
FIGURE 7 – Severe pitting in an AISI 304 cold water tank caused by lack of final surface treatment of the weld between the tank shell and the flat iron used for attachment of the inlet pipe. Moreover, pitting was also observed in a heat tinted area on the tank shell as a result of lack of post-treatment after external welding of support for a rectangular hollow section.

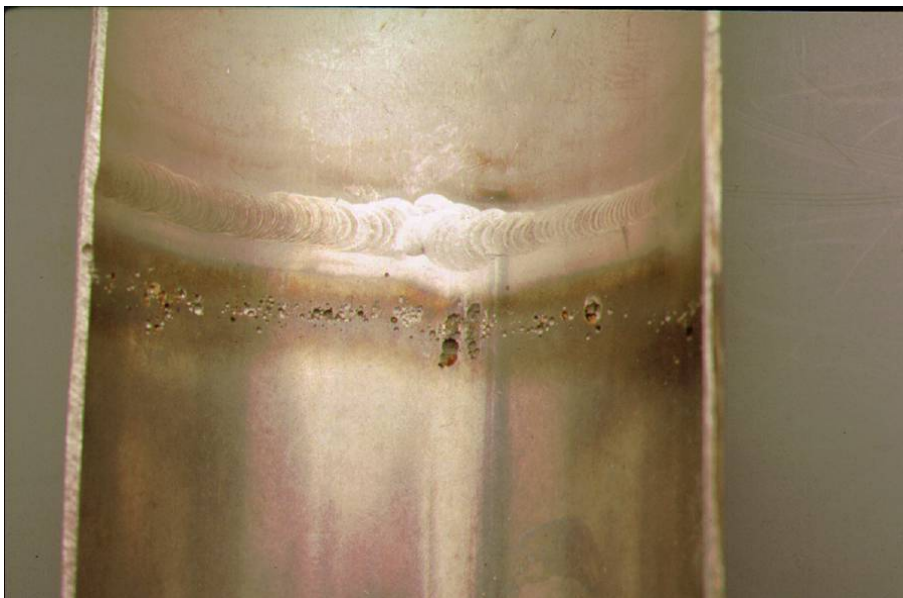
FIGURE 8 – Pitting in the HAZ of an AISI 316 tube characterized by heat tint. In this case where the root geometry is “reasonable”, pickling would have been an adequate surface treatment to re-establish the corrosion resistance.

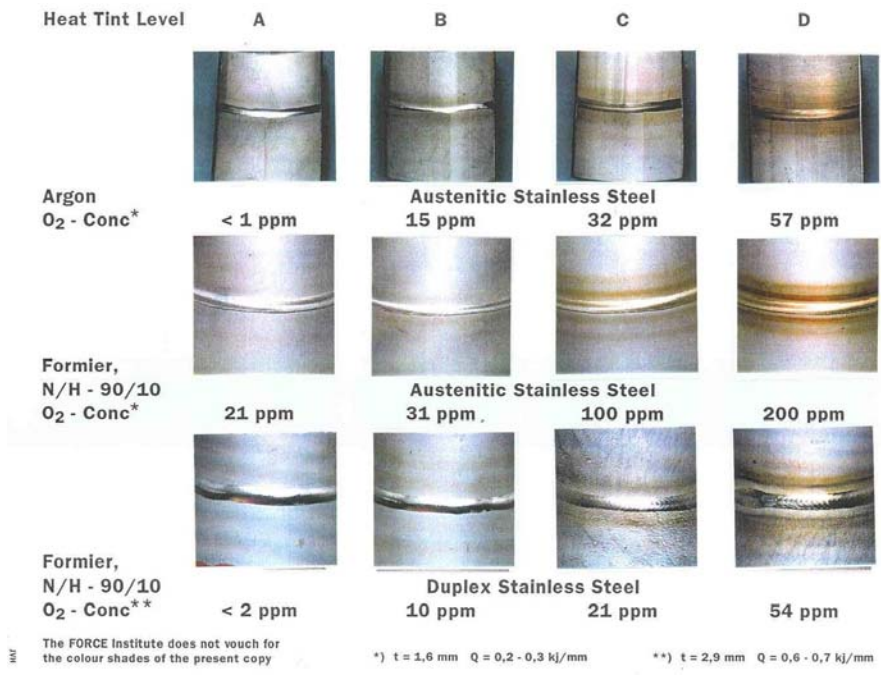
FIGURE 9 – Reference atlas for heat tint (FORCE report 94.34).

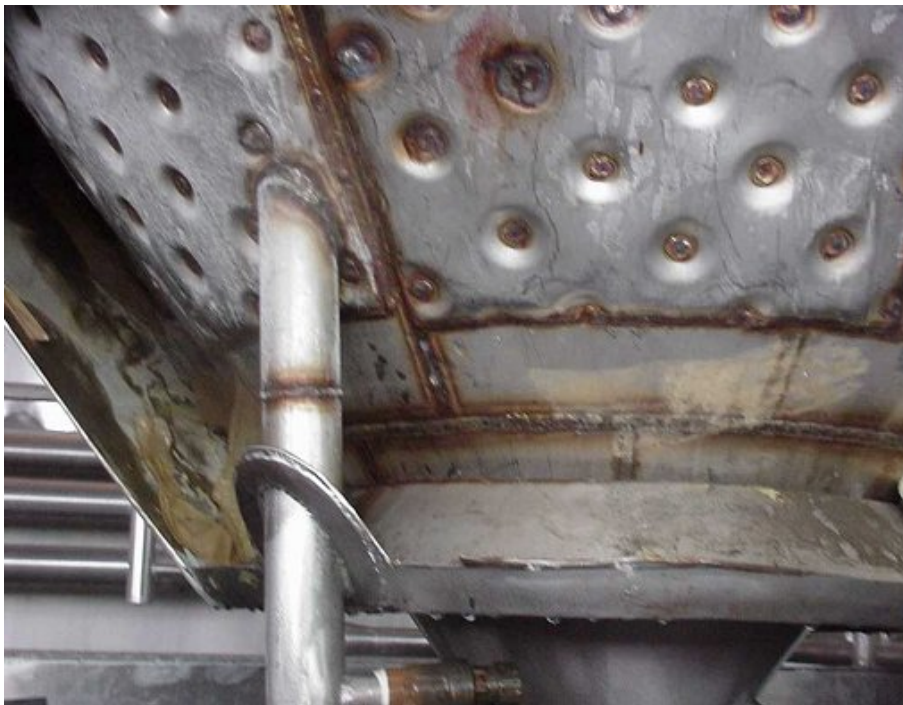
FIGURE 14 – Overview of the bottom of the yeast storage tank after removal of the insulating material. The great majority of the repair-welded dimples were observed in clusters. Unlike the original welds at the dimples between the jacket and the tank bottom, it seemed that the repair welding had been performed using filler material.

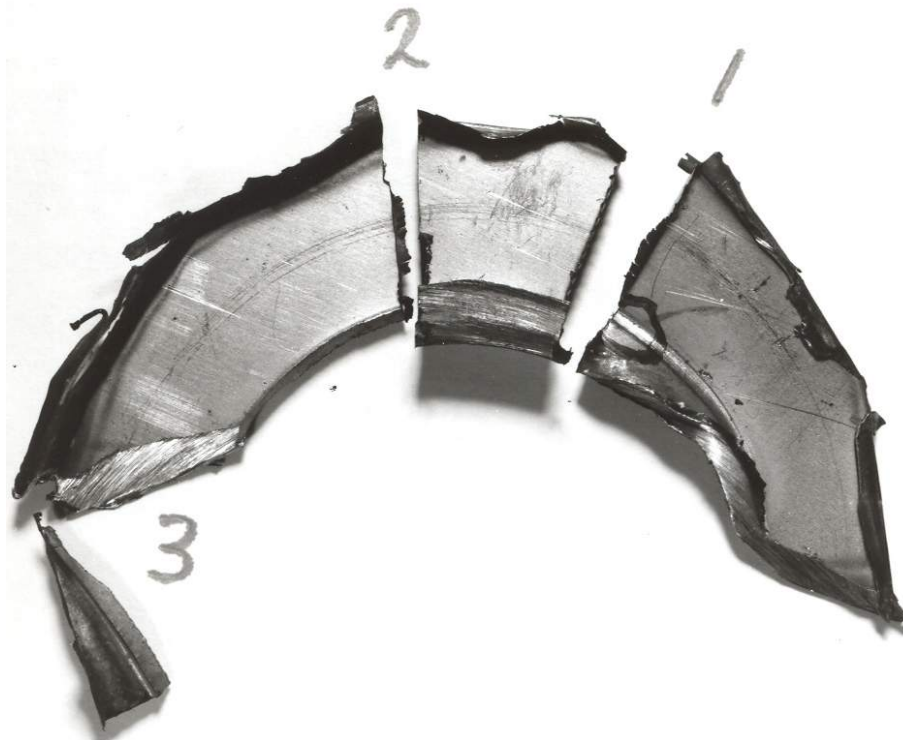
FIGURE 15 – Macrograph of damaged dimple plate with the internal side of cooling jacket uppermost. Crack was opened at position 3 so fractured surface could be studied. At cut 2, a microsection was taken. Magnification 2x.

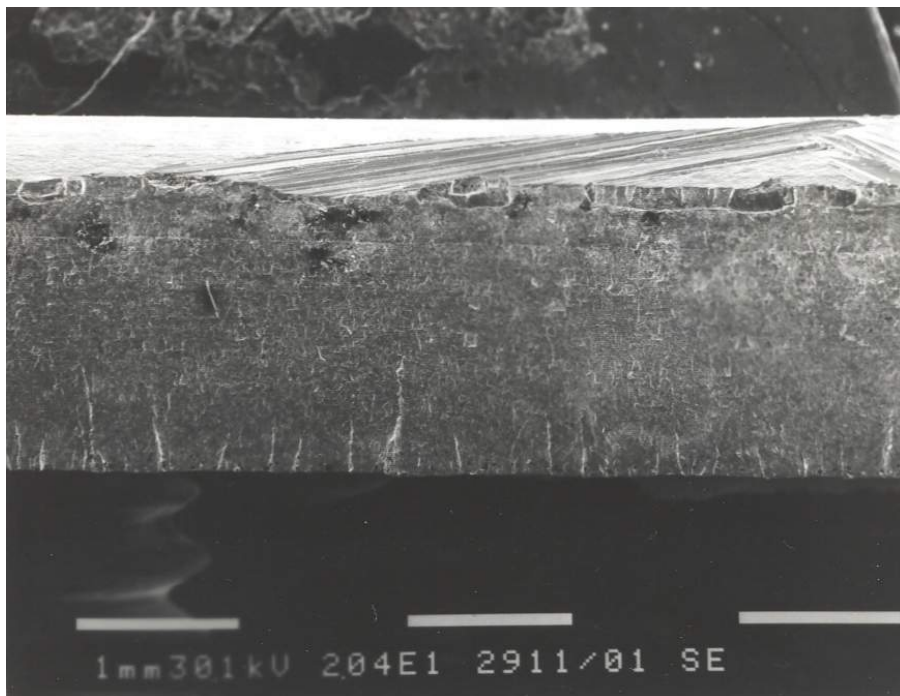
FIGURE 16 – SEM-micrograph of part of the fractured surface (see mark 3 on figure 15) with internal side of the cooling jacket at the bottom of the micrograph. Note the presence of beach marks and steps (“notches”). Magnification 20.4x.

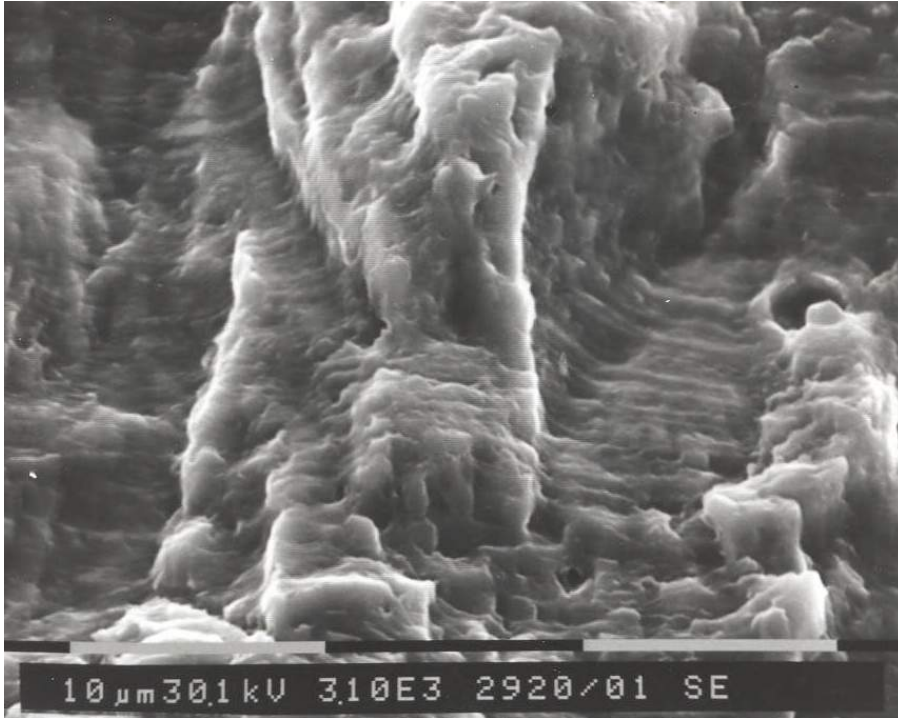
FIGURE 17 – SEM-micrograph at high magnification of fractured surface on figure 16. Note the presence of striations. Magnification 3100x.

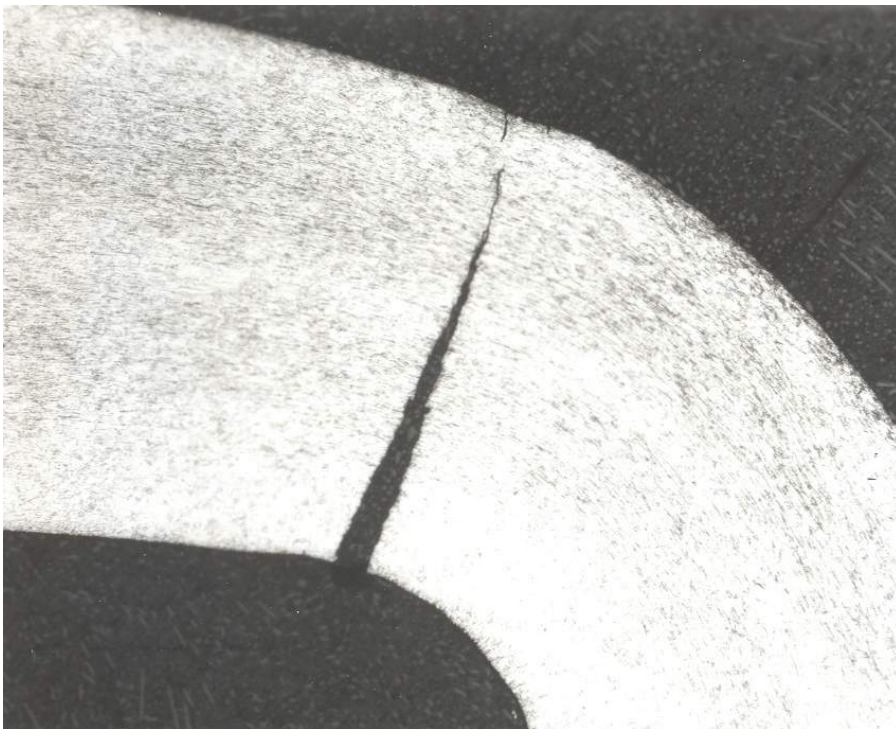
FIGURE 18 – LOM-micrograph of cross-section of cooling jacket, see cut 2 on figure 15. The cracks are localized to the knuckle area of the dimple. The large crack enters from the internal side of cooling jacket. Magnification 3100x.

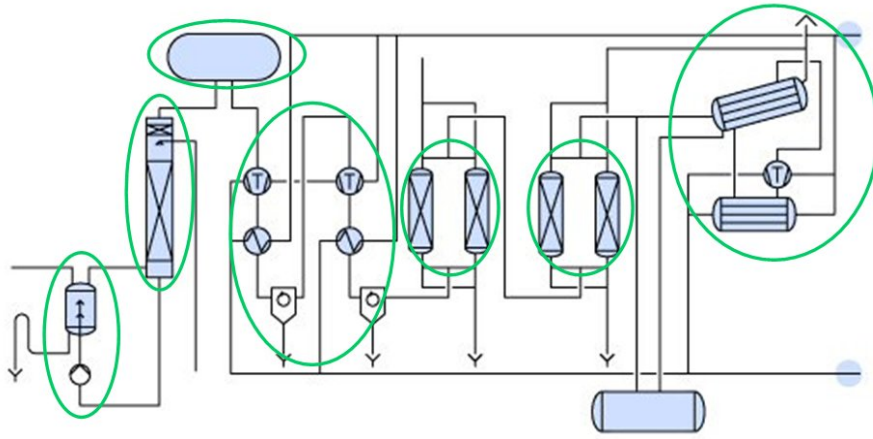
FIGURE 19 – The carbon dioxide recovery plant consists of seven operating steps; a foam trap, a water scrubber, a balloon, a CO₂ compressor, an activated carbon filter, a dehydrator and a refrigeration unit.

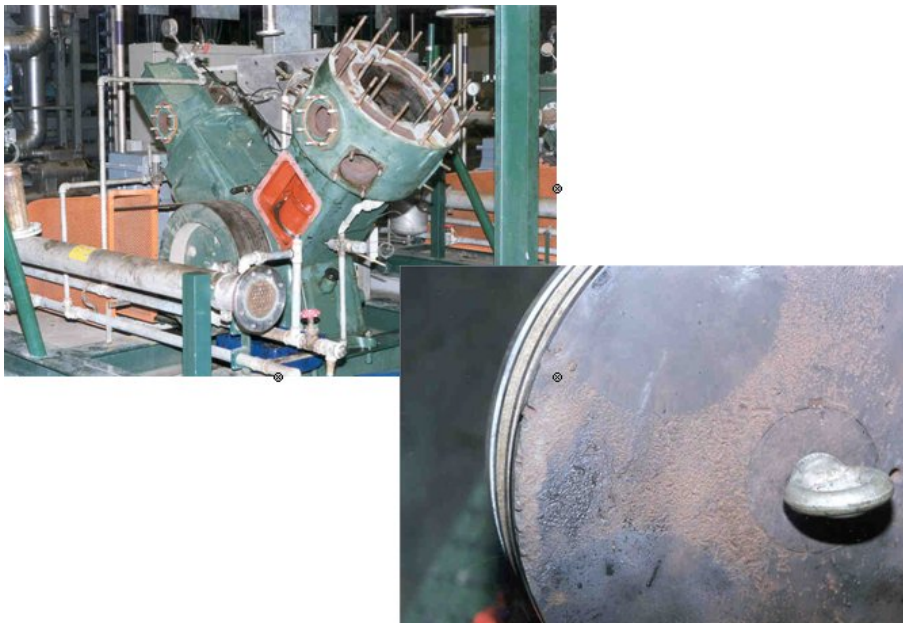
FIGURE 22 – The V-compressor was dismantled and it was seen that the gas side of the compressor suffered substantial uniform corrosion. Furthermore, the piston and the cylinder lining showed signs of wear and mechanical damage.

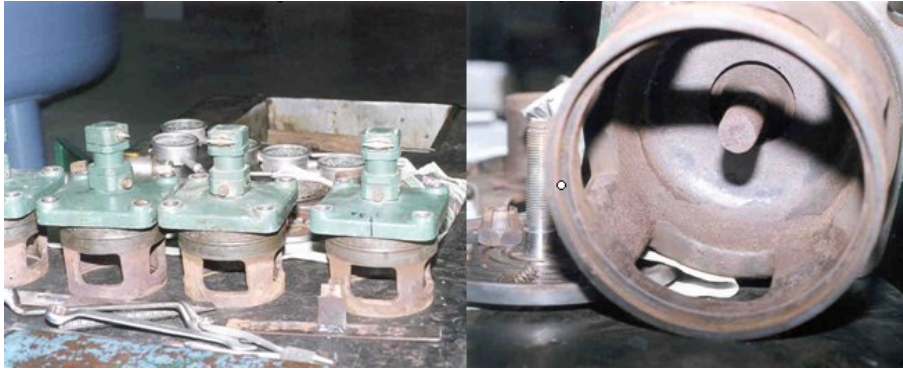
FIGURE 23 – Valve casings dismantled from the V-compressor. The valve casings were covered with corrosion products.

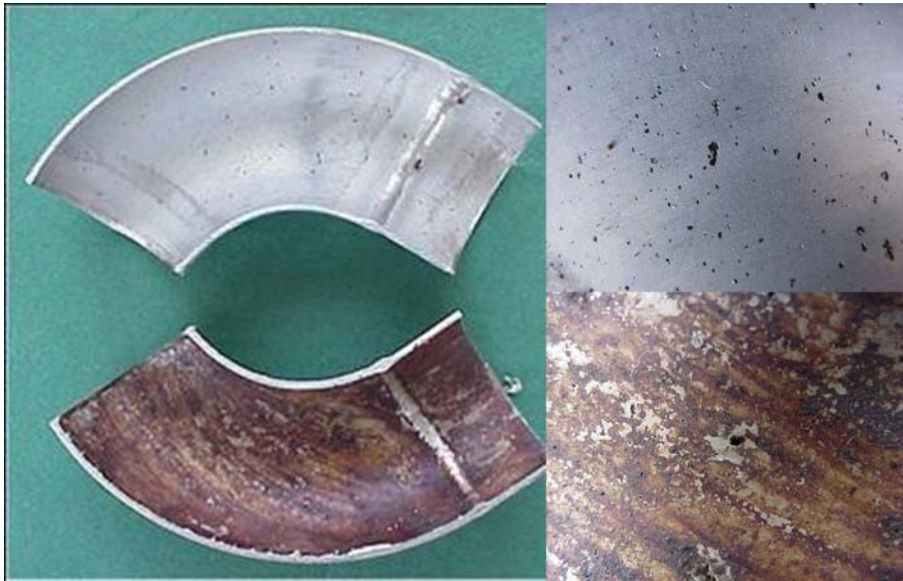
FIGURE 24 – The photos show the cut open piping (after cleaning at the top) between the 2nd stage separator and 2nd stage compressor. Severe pitting corrosion initiated from the gas side was observed.
