Unexpected corrosion of stainless steel in low chloride waters – microbial aspects

**Lisbeth Rischel HILBERT¹, Leena CARPÉN², Per MØLLER³, Frank FONTENAY¹,
Troels MATHIESEN¹**

Abstract

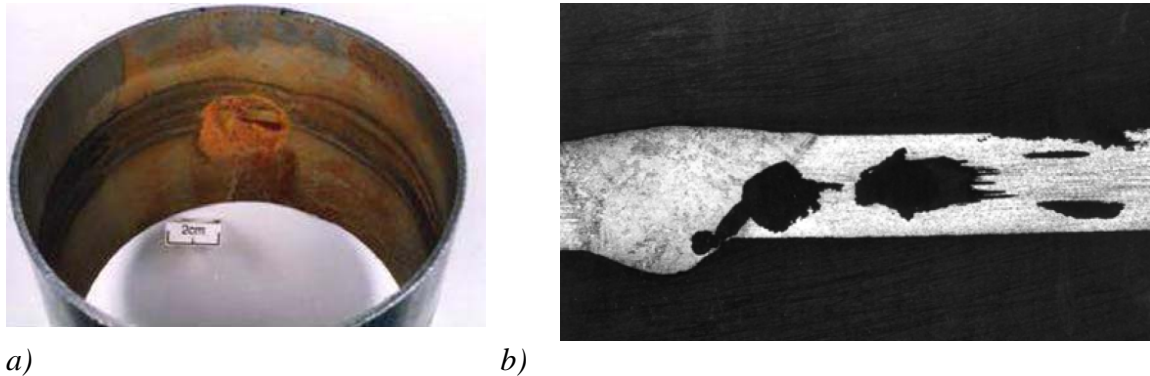
In a fire protection system in a power plant perforating pits were found in stainless steel (EN 1.4401) pipes \varnothing 140 mm of 3 mm wall thickness after two years of service [10, 11]. The system included both older parts of carbon steel and cast iron and newer, replaced parts of

stainless steel 1.4401 and 1.4301. The water was tap water (drinking water) with low chloride content of 20-30 mg/l and the system was at ambient temperature. The water was chloramine treated when the system was filled, and water was exchanged typically once a year. The pits were situated in the welds or in the heat affected zones. Pipes of EN 1.4301 were also attacked and leaks detected after two years of service. Typically the pits were very small having large subsurface cavities. In general the pits were situated close to or in the transversal on-site welds. There were clear indications of oxidation of the heat affected zone (heat tints) but no other signs for welding defects were found. Reddish brown deposits were found and the pits were surrounded by dark brown circular deposit rings and the inner surfaces of the pipes were mostly covered with a thin and rather smooth layer of a yellowish brown deposit.

Fig. 1 a) Reddish brown deposit on the inner surface of a stainless steel type 1.4401 pipe section removed from the fire protection system. b) Optical micrograph of a wall-through, mainly subsurface corrosion pit in 1.4401 pipe after two years of service in the system.

Sulphur and occasionally also high amounts of manganese as well as small amounts of phosphorous were detected in the deposits in or around the pits by energy dispersive spectroscopy (EDS). This indicates that manganese probably exist as MnO_2 (a compound formed by aerobic bacteria) and S as a sulphide formed by the reduction SO_4^{2-} . SRB and a high amount of aerobic bacteria ($4.3 \cdot 10^6$ cfu/ml) could be detected in a sample that was delivered moist to the laboratory and cultivated in microbiological assays. The samples for microbiological analysis had wall-through pits. The presence of IOB was verified in one pipe sample and in the water, but the presence of MOB was not checked.

The water contained high amounts of precipitated iron (0.44 mg/l measured after two years service) which can facilitate iron oxidizing bacteria but could also in itself affect the risk of localized corrosion of stainless steel.

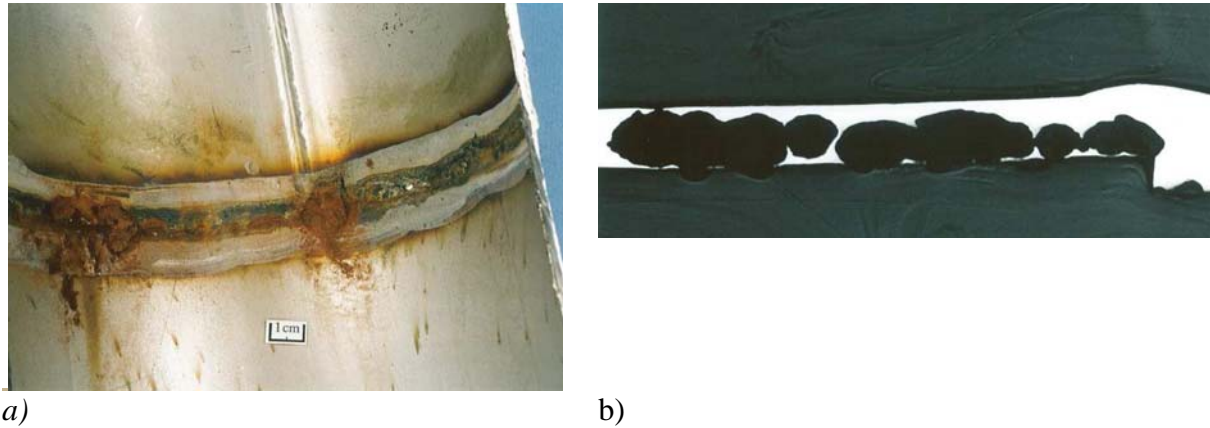
In the condenser pipe of an air conditioning system designed in stainless steel 1.4301, the first leak was observed after just a couple of months service [11]. The water was a mixture of ground water and drinking water with 120 mg/l chloride. Apart from some short stagnant periods of operation the system had been generally flowing continuously with 1 m/s. The maximum temperature was 30 °C.

The attacked areas were all in the weld or in close vicinity of the welds. These were covered with reddish brown deposits, and the investigations showed that the weld quality was poor. Remains of root paste could be seen, which has been used to form a slag layer on the root side

of the weld to protect the weld root from oxidation. The weld itself was partly corroded, but pits were also present in the heat affected zone. High amounts of manganese, chromium, iron, and smaller amounts of sulphur, phosphorus, and chlorine were found by EDS in deposits covering the pits. Bacteria were detected in the failure area with a total aerobic count of $7.8 \cdot 10^3$ - $1.4 \cdot 10^4$ cfu/ml and SRB 54 cfu/ml.

Fig. 2. a) Reddish brown deposits on the inner surface of a stainless steel type 1.4301 condenser pipe section removed from the air conditioning system b) Optical micrograph of severe wall-through corrosion pits in 1.4301 pipe after few months of service in the system.

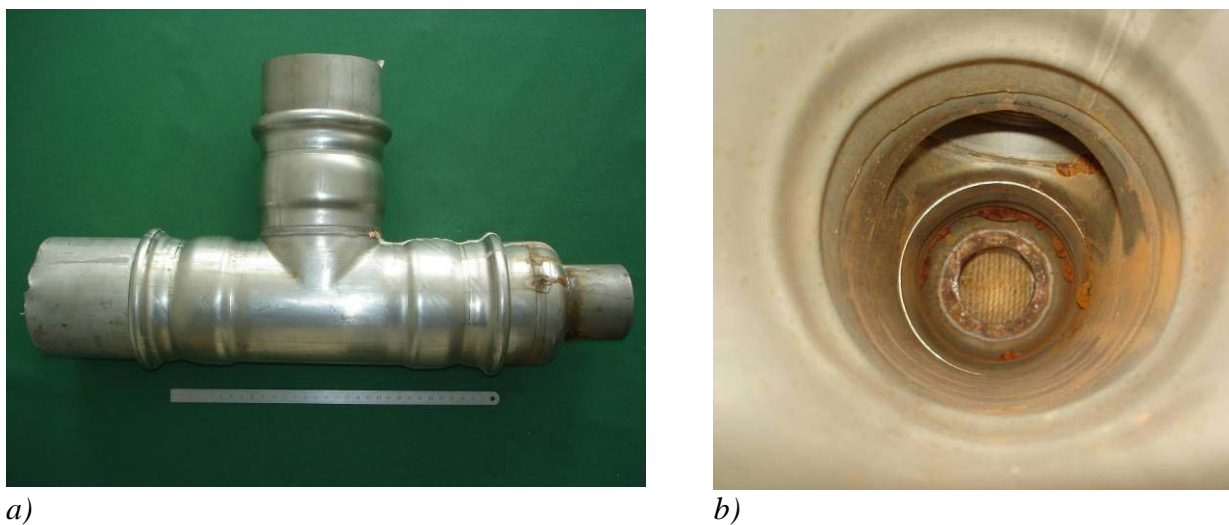
Fig. 3. a) Press fitting for large dimension pipes perforated after less than 1 year service with lukewarm drinking water. b) Inside of fitting showing red brown tubercles at welds.

As shown in fig. 3 the corrosion attacks were covered by tubercles. Sulphide was qualitatively detected in the crevices at corrosion attacks by an iodazide test, but not directly in the tubercles. The sulphide could originate from the presence of SRB, but no microbiological analysis was performed.

In this case the primary critical parameter was defects in welds, which were found by metallographical examinations. To avoid this type of failure better weld quality must be specified (root defects, crater pores, lack of fusion) and then the normal pickling procedure will ensure resistant fittings without sensitive areas. However, it is likely that a high degree of microbiological activity has enhanced the critical situation and helped build tubercles under which corrosion attacks continued. According to the Danish Code of Practice for domestic water installations [14] no place in the system should the hot water temperature be lower than 50°C, and 45 °C at peak load. This is to reduce the risk of bacterial growth of especially pathogen bacteria such as *Legionella*, but it would also help to reduce the risk of MIC. Furthermore the use of circulating lukewarm water is unwise from both a hygienic and a corrosion point of view.

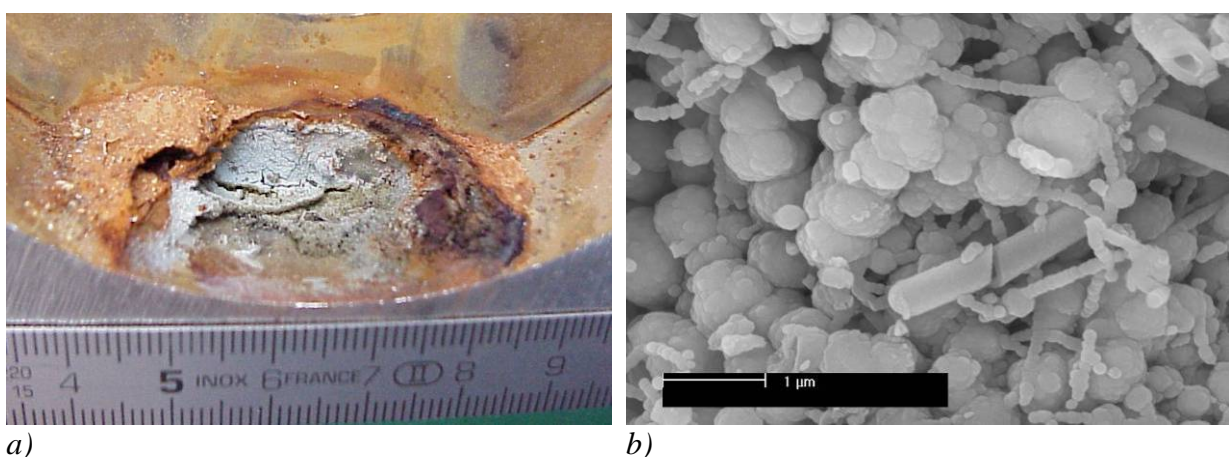
Another case [12] is from a fire protection system in stainless steel, EN 1.4401/1.4404. The system was filled with drinking water containing 100-130 mg/l chloride, which resided in the system at about 10°C. Two years after installation several small leakages were observed in the system. Corrosion was observed in association with heat tints and crevices (i.e. weak areas). Indicative potential measurements in the system showed a level of up to 560 mV vs. SHE (~320 mV SCE), indicating that ennoblement had occurred. There were no signs of manganese deposits, but voluminous rust tubercles, Fig. 4a, were found.

Chemical analyses of the products in the tubercle showed high amounts of the steel elements, i.e. iron, chromium, nickel and a surprisingly high concentration of molybdenum. Moreover, a wide variety of organic deposits expected to be of microbiological origin were observed, Fig. 4b, which were taken as remnants of bacteria, e.g. sheets of rod shaped bacteria.

Fig. 4 a) Voluminous rust tubercle at crevice inside a stainless steel junction (1.4404) of fire water system. b) Scanning electron micrograph of the products in the rust tubercle expected to be of microbiological origin, e.g. bacteria sheets.

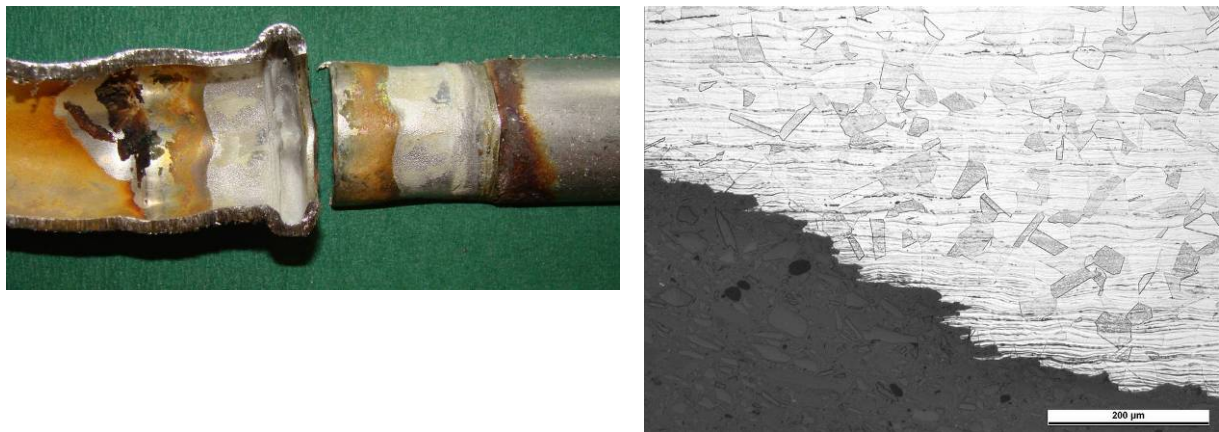
In the drinking water installations of EN 1.4404 in the student house in a major Danish city, rust stains were detected at cold water press fittings after 1 year in service, but no leaks were apparent. The failure analysis was conducted after 2½ years service, when the fittings and pipe sections were cut out. The hot water installations did not seem affected by corrosion. A water analysis performed on water from the basement revealed high manganese (0.11 mg/l) and iron (1.2 mg/l) contents in the water, which exceeded the allowed values of Mn 0.05 mg/l and Fe 0.2 in drinking water as delivered from the water works. The origin of Mn and Fe were not identified, but could be related to corrosion in the system. Corrosion attacks were severe crevice corrosion attacks in fittings and pipe, preferably under the o-rings. At the crevice opening voluminous tubercles were found, and inside the pipes reddish brown deposits covered larger areas. Qualitative iodazide tests indicated sulphide in deposits close to the corrosion attacks. Some of the press fitting connections had an oily appearance as if some organic substance had been leaking from the o-ring or was applied for lubrication during installation.

a) *Crevice corrosion in press fittings of drinking water installations of EN 1.4404 after 2½ years in service.* b) *Optical micrograph of edge along the corrosion front. The microstructure appears normal for 1.4404.*

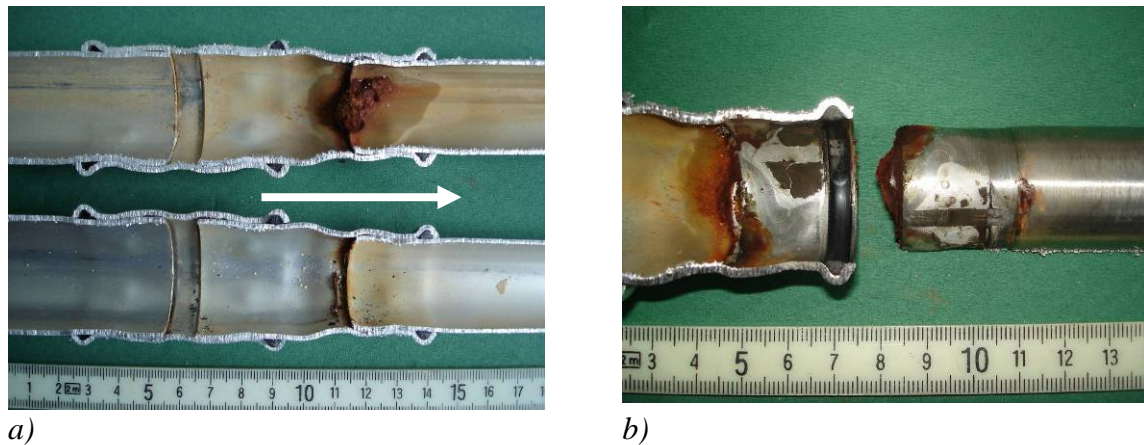
In the drinking water system in a university building in the same city as case 5, a very fast development of crevice corrosion was found. In less than 4 months rust stains developed at press fittings of EN 1.4404 and minor leaks occurred. In this case the cold water pipes were hardly affected but corrosion occurred in the warm water installations of maximum temperature 55 °C, and primarily on pipes of smaller diameter $\varnothing 35$ mm. After installation the system was filled with water that was circulated at 55 °C for an unknown period of time, until the building was taken into use. The water quality was considered acceptable being neutral, of medium hardness, medium conductivity, medium chloride, and with some organic matter and acceptable cell counts.

As in case 5 crevice corrosion attacks were found in fittings and pipe, especially under o-ring, and the corrosion attacks were characterized by voluminous tubercles and brown surface deposits. In the dark brown deposits in the corroded zone, sulphide was qualitatively detected by iodazide test. From the distribution of corrosion products and deposits (fig. 6b) there are indications that standstill and half filled pipes have been occurring. It was reported that water was circulated until the system was taken into use, but if this has not been the case or the

system has not been full of water, this could explain the very fast corrosion attacks combined with the growth of bacteria occurring in stagnating and perhaps oxygen depleted warm water.

Fig. 6. a) Crevice corrosion in press fittings of drinking water installations of EN 1.4404 after 4 months in service. Note tubercles and lack of deposits in one of the pipe halves. Flow direction is marked by arrow b) Corrosion attacks are both on pipe and fitting. Deposits inside crevice are dark gray, brown to green.

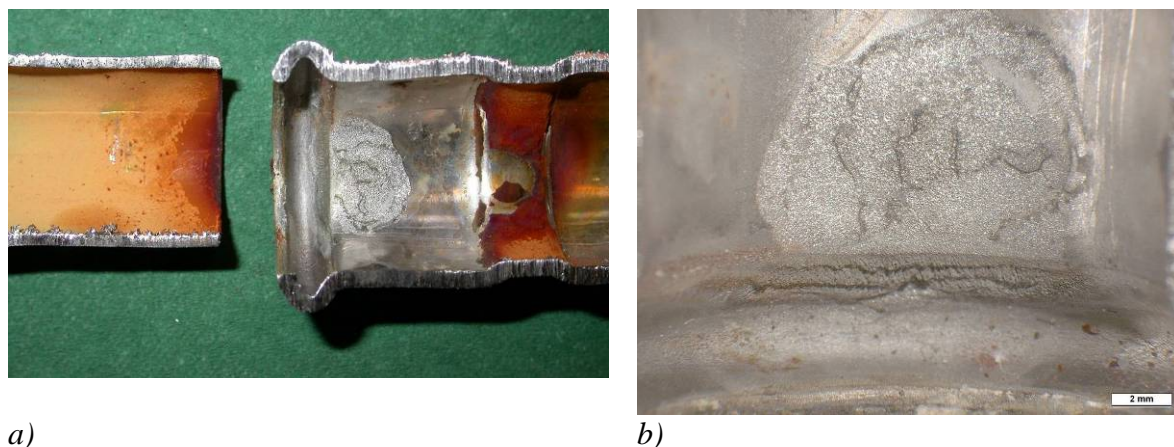
The last case of press fitting corrosion is from another major Danish city and from an apartment house. After only 9 months of service small leaks were detected and rust stains were visible at press fitting connections. In this case the water quality was questionable, although still accepted as drinking water in Denmark. The water was neutral, of high hardness, high conductivity, high chloride content, and both some organic matter and quite high cell counts were found.

Fig. 7. Crevice corrosion in press fittings of cold drinking water installations of EN 1.4404 after 9 months in service. b) The area close to the o-ring is severely attacked and appears bright and etched.

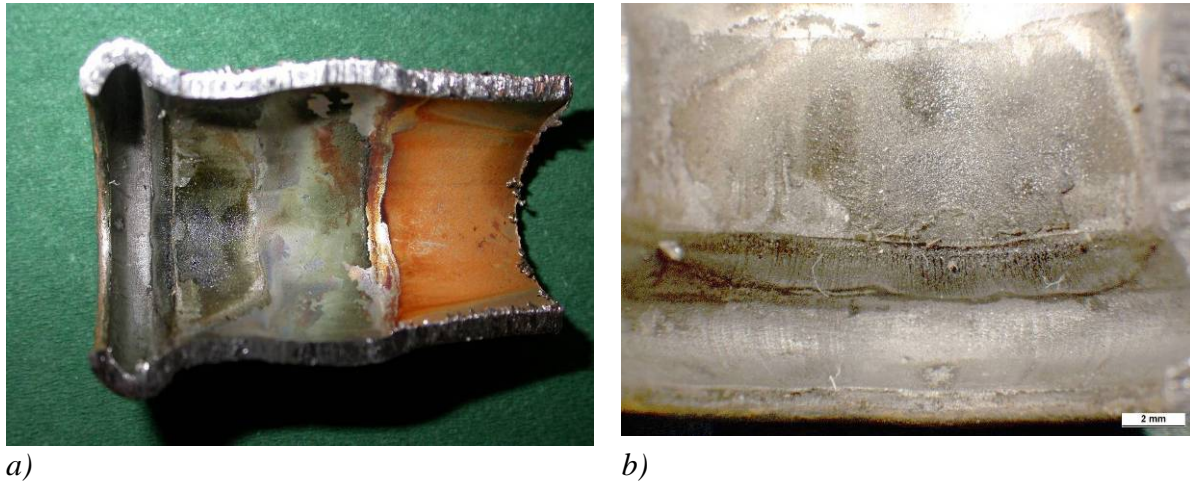
The material used was EN 1.4404 and crevice corrosion was found in the fittings and pipes, especially under the o-ring. The warm water installations were severely affected, but attacks were also found in the cold water installations. The corrosion attacks were primarily in the

horizontal pipes, but attacks were also encountered in vertical pipes. As for the previously described case voluminous tubercles were found at the crevice mouth and outside the crevice red brown surface deposits were present. Inside the crevice deposits were darker, grey to green and sulphide was confirmed qualitatively in deposits by iodazide test. The o-rings appeared greasy and sticky, and remains of pale yellow grease was observed, which might have been used during assembly or has leaked from the o-ring. IRS analysis indicated that the grease was mineral oil based.

Fig. 8. Crevice corrosion in press fittings of hot drinking water installations of EN 1.4404 after 9 months in service. Note green to dark grey deposits in the crevice. b) The area close to the o-ring is severely attacked and appears bright and etched.

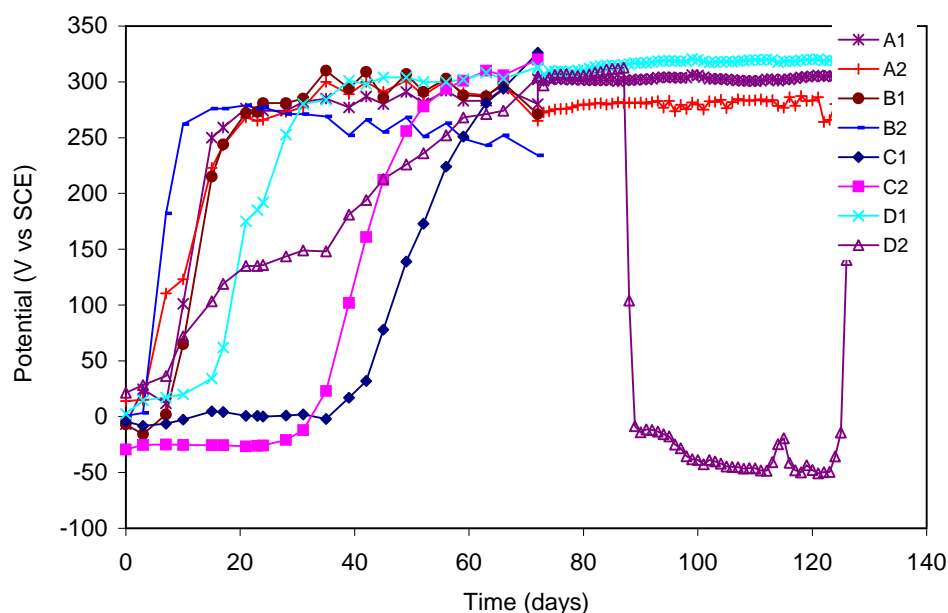
Fig. 9. EN 1.4401 stainless steel fittings exposed under stagnant conditions in four Danish drinking water types (A-D) at 22°C. Ennoblement occurs for all after 5 to 60 days up to the range of 275-310 mV vs. SCE (518-553 mV vs. SHE). Temporary activation is seen for one sample after 85 days, but no penetrations were detected [12, 15].

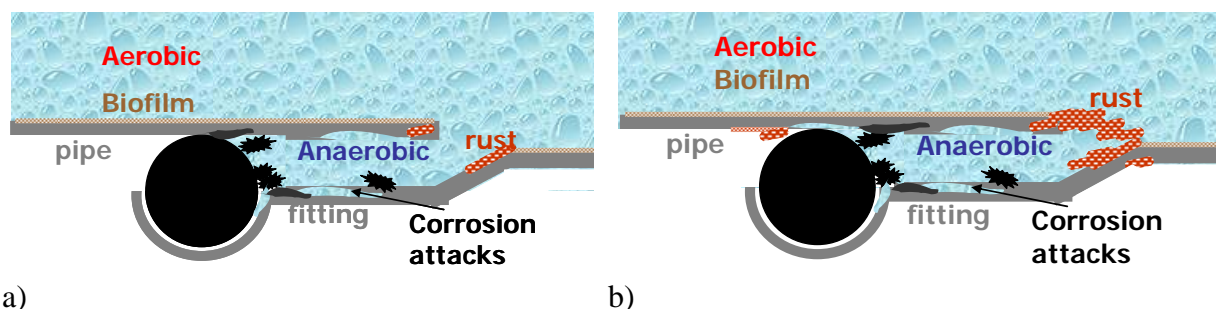
The mechanism of crevice corrosion in press fittings can be described as a line of events starting with ennoblement of the pipe due to aerobic biofilm formation. This increases the risk of crevice corrosion, but the pitting potential for the pipe surface is not exceeded. In the crevice media is changed with time, and probably effects of iron-oxidizing bacteria that may thrive under microaerobic (low-oxygen) conditions using Fe(II) as a sole energy source are involved. The iron oxidising bacteria produce ferric iron, which in combination with chloride ions produces aggressive ferric chloride. Mn oxidizers (Mn^{2+} to Mn^{4+} forming MnO_2) are important in fresh water and waste water MIC introducing a strong oxidant causing potential increase, but is probably not as important in drinking water, where manganese concentration is often low, except if a source of Mn like corroding steel is present.

If anaerobic conditions are formed in the crevice production of sulphide may occur e.g. by growth of SRB. The effect is a lowering of the redox potential in deposits on the surface by producing sulphides and formation of metal sulphides that may act as efficient cathodes. The number of SRB is usually low in drinking water, but given the right conditions they grow. In presence of air, sulphide may be oxidized to thiosulphate generally accepted to enhance the corrosion of stainless steel, especially if conditions are alternating anaerobic/aerobic. Furthermore the reduction of pitting potential as a function of the ratio between chloride and thiosulphate concentration was presented more than 30 years ago [16].

The o-ring material and possible assembly aids are important in the respect that they may leak organic material/chemicals that can be utilized by the bacteria and change the microenvironment. Corrosion attacks in the press fittings appear mostly in areas next to sulphides and under the o-rings. The crevice is often found to be closed by corrosion products limiting the contact to the rest of the pipe surfaces and limiting the exchange of media. In many of the Danish experiences a small leak has appeared and the corrosion attack seems to stop by this event. The leak gives the possibility of air ingress and loss of aggressive media thereby possibly seizing the growth of specific bacteria, as well as facilitating oxidation of sulphides. Furthermore the corrosion products have isolated the crevice from the rest of the pipe. This last observation is controversial in the respect that a minor leakage can then actually be considered a positive event, after which the corrosion attack will cease and long lifetime of the connection is expected.

Fig. 10. Suggested mechanism for crevice corrosion in press fitting. a) Formation of aerobic biofilm on pipe surface, depletion of oxygen in crevice leading to initiation of crevice corrosion attack in combination with IOB and SRB activity. b) Leakage due to penetration leads to oxygen ingress and loss of corrosive media –corrosion attack ceases and corrosion products close the crevice.

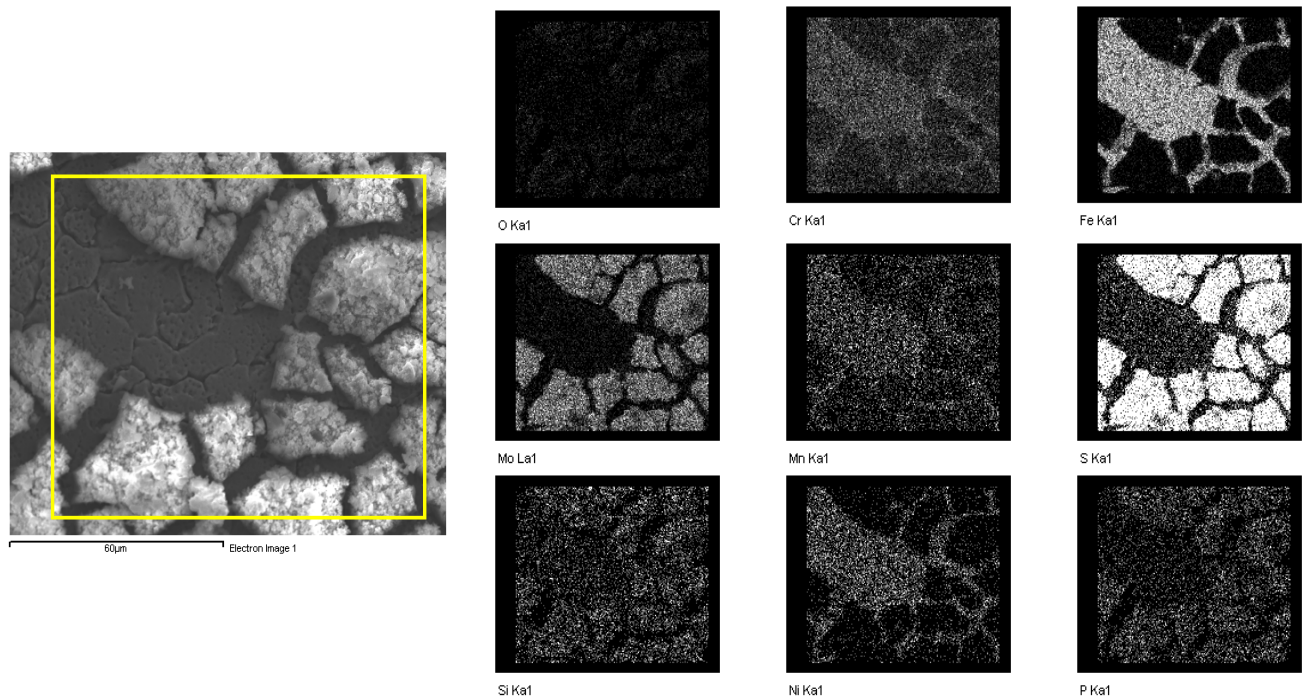
major city described in cases 1-3 and occurred in the same time frame. In this case rust stains appear after < 2 years of service and crevice corrosion was observed. Corrosion products inside the crevice under the o-ring revealed high concentrations of Mo and S in the same areas as illustrated in fig 11.

Fig 11. Scanning electron micrograph showing corrosion products in the crevice of a corroded press fitting. Mapping of elements indicated presence of molybdenum sulphides and EDS analysis showed 4 S and 9 Mo atomic % (3.4 and 23 % by weight).

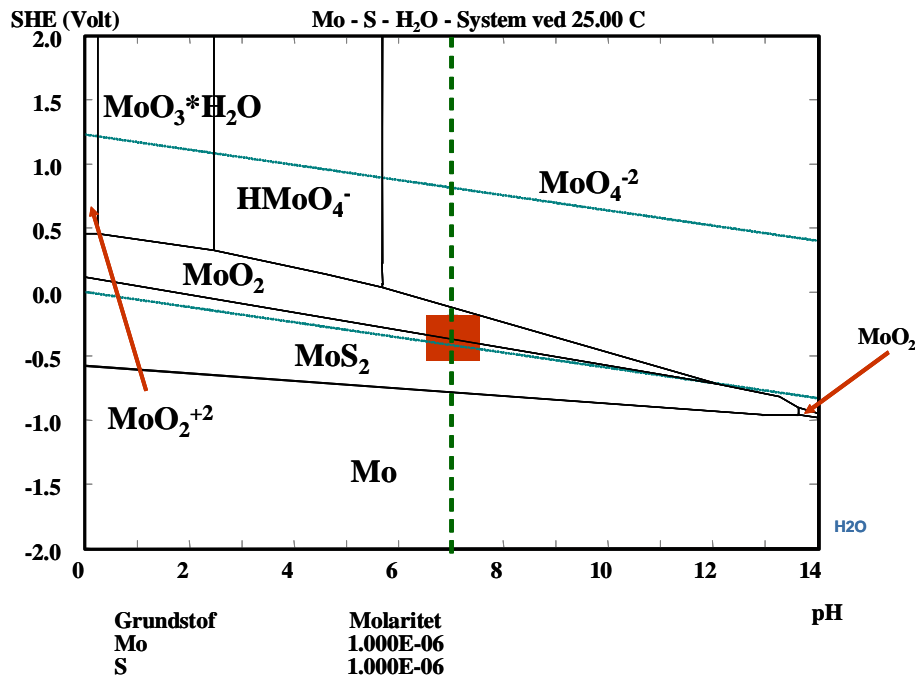
On the specific stainless steel samples XPS was not used for documentation, but only EDS, which unfortunately is less reliable due to overlapping of the S and Mo signals. This especially is a problem for the presence of small amounts of the two elements. In other cases the appearance of high amounts of Mo and S in the same area has been detected by EDS, but generally not taken as more than indications. Chemical analysis by e.g. ICP or XPS should therefore be applied for better documentation and it would be interesting to follow this line of thought and examine whether MoS_2 is really a part of the mechanism for stainless steel press fittings.

Fig.12. Pourbaix diagramme for Mo and S at 25°C and $1 \cdot 10^{-6}$ mol/l of Mo and S species. The stability area of MoS_2 is at lower redox potentials.
