## **UNUSUAL CORROSION FAILURES OF STAINLESS STEEL IN LOW CHLORIDE WATERS**

Troels Mathiesen, Jan Elkjaer Frantsen  
FORCE Technology  
Park Alle 345  
DK-2605 Brøndby, Denmark  
trm@force.dk

### **ABSTRACT**

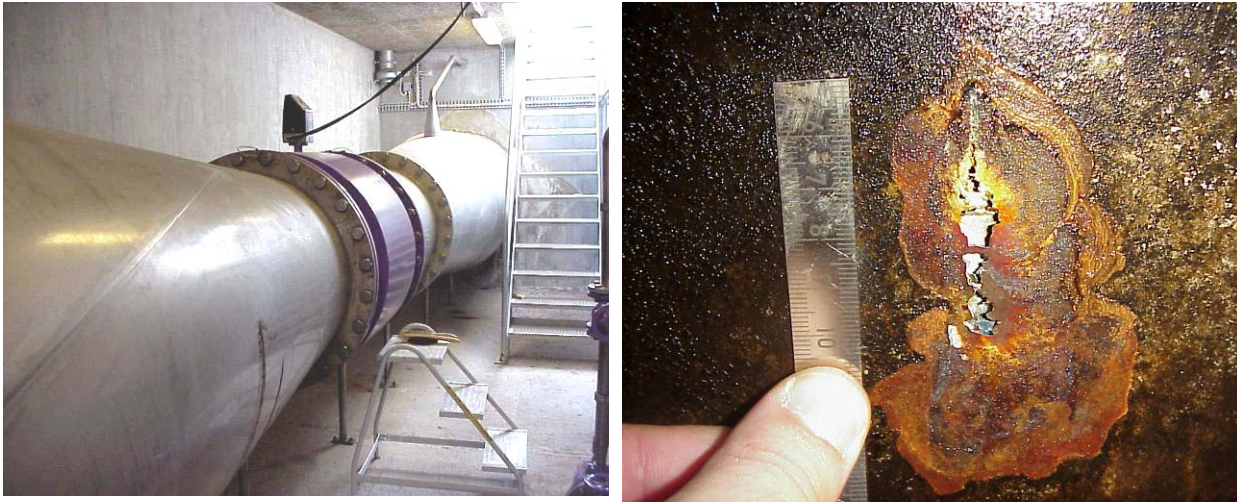
A survey that included 62 Danish sewage treatment plants showed that 60% had experienced corrosion failures with stainless steel, and most failures (80%) were located in installations near the final stage, i.e. secondary clarification, sand filter or piping for discharging and recycling treated water. Inspections of 18 sewage plants showed that most failures occurring in the treated waste water were associated with extensive deposits of manganese dioxide on the internal surface of the stainless parts, Figure 2.

It was further shown that the deposition of manganese dioxide was an extremely selective process that took place even in waters where the dissolved manganese was less than 6 µg/l. Several groups of bacteria enable oxidation and precipitation of manganese and iron oxides. These bacteria are generally characterized as ferro/manganese oxidizers and include *Galionella* as the best-known example in relation to corrosion.

As a result of this, highly oxidizing conditions were generated by the manganese dioxide deposits on the steel surface. Measurements of the corrosion potential in the waste water showed a steady level of 450-500 mV SCE that was typically reached within 30-60 days after exposing fresh samples. Bacterial analysis of several water samples from the affected installation did not provide a clear correlation between the test results and the observed manganese deposition.

FIGURE 2 - Pits in AISI 304 base material at the outlet flow meter in sewage treatment plant H. a) overview showing two penetrations, b) extensive attack surrounded by  $\text{MnO}_2$  deposits on the inside.

Given the extreme oxidising conditions, failures were quite frequent in the AISI 304 type installations. For parts made from AISI 316, strict precautions should be taken regarding weld quality and surface treatment in order to avoid localised corrosion.

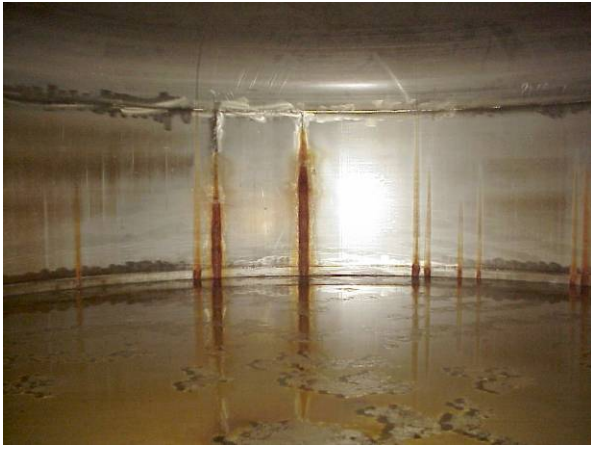
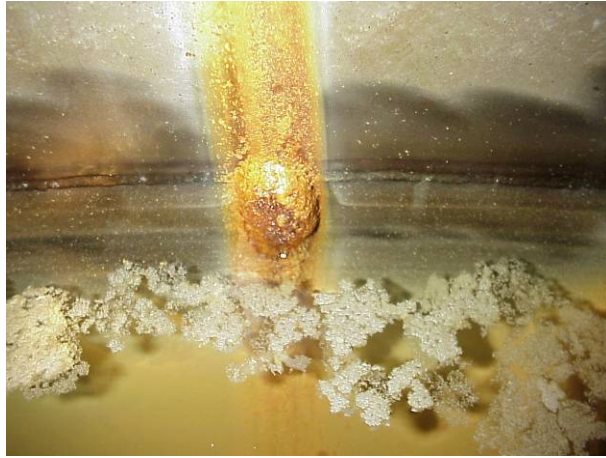
Another example of unusual corrosion is the feed tank for a water treatment plant. The tank was made from AISI 316 type stainless steel and contained drinking water with a chloride content of 56 mg/l. Due to delayed start-up of the water treatment plant, the tank had unintentionally remained water-filled at ambient temperature for two years. During an inspection just before start-up, several rust formations were observed along the welds, Figure 3. Small penetrations could also be seen on the outside.

At close hand, it was noticed that large rust tubercles had been built up in association with the corrosion. Moreover, clouds of microbial growth were floating in water. The measurement of the corrosion potential showed +400 mV SCE.

The weld quality was not poor, but could on the other hand have been better. Although the measured potential was higher than expected, it was still surprising that the AISI 316 welds were attacked by corrosion in water with just 56 mg/l chloride at 20°C.

FIGURE 3 - a) Vertical lines of rust products from welds inside the storage tank containing stagnant water. b) Close-up of rust tubercle, approx. 30 mm in diameter.

The tank was repaired immediately and no further investigations were requested to analyse the exact cause of corrosion.

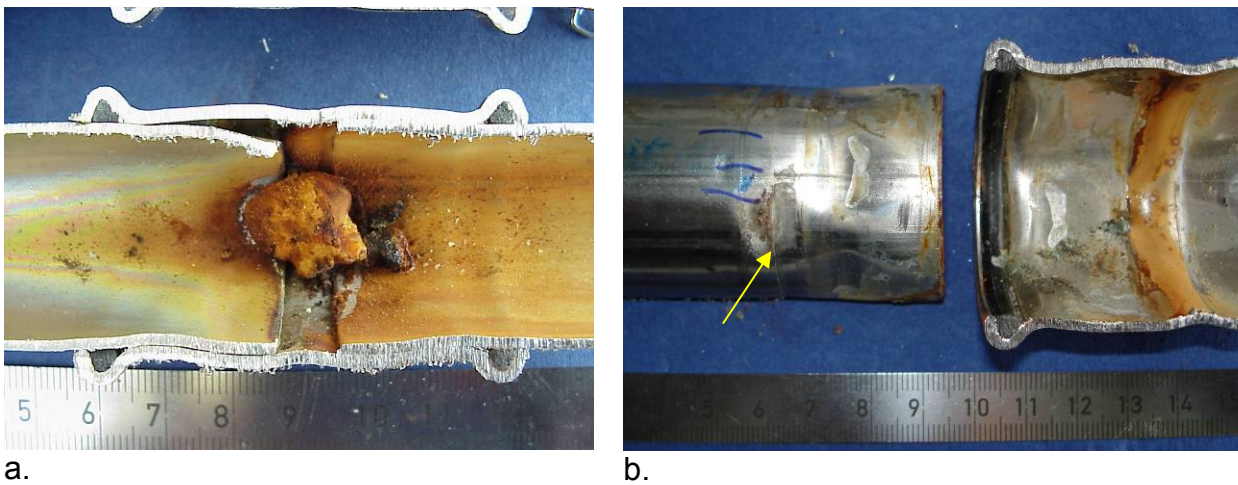
As shown in Figure 5, the corrosion is associated with build-up of large rust tubercles. There is no evident deposition of manganese dioxide or other products that generate highly oxidizing conditions. When potential measurements could be performed, the recorded level was 250 to 350 mV SCE. This level should not cause crevice corrosion of stainless steel why other potential mechanisms were evaluated. Chemical analysis of the products inside the crevice performed by SEM-EDS showed, in some cases, an increased content of sulphur. However, this determination was complicated by the overlap of molybdenum in the spectra.

In some cases the iodine azide showed a positive response, which indicates presence of sulphide in the crevice.

FIGURE 5 - a) Rust tubercle in press fitting of a drinking water system. b) Corroded area causing leakage between O-ring and pipe at the bottom of the crevice.

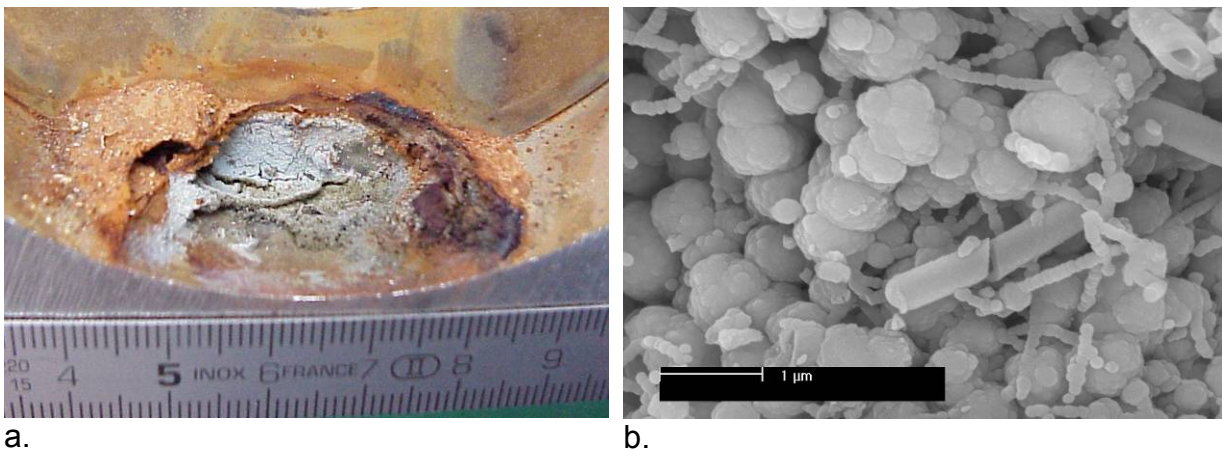
The last example of “rare” corrosion cases originates from a fire water system that was built entirely from stainless steel, type AISI 316 or AISI 316L. The system was filled with drinking water containing 100-130 mg/l chloride, which resided in the system at about 10°C. Two years after installation several small leakages were observed in the system. Although, corrosion was observed in association with heat tints and crevices (i.e. weak areas) it was still somewhat surprising that penetrating corrosion had developed. Indicative potential measurements in the system showed a level up to 320 mV SCE. Moreover, there were no signs of manganese deposits. Otherwise, the corrosion had the same features as the above examples, i.e. voluminous rust tubercles, Figure 6a.

Chemical analysis of the products in the tubercle showed high amounts of the steel elements, i.e. iron, chromium, nickel and molybdenum. Moreover, a wide variety of organic compounds were observed, Figure 6b.

FIGURE 6 - a) Voluminous rust tubercle at crevice inside a stainless steel junction (AISI 316L) of fire water system. b) Scanning electron micrograph of the products in the rust tubercle.
