## **Corrosion of brass in drinking water with high alkalinity**

*Asbjørn Andersen, Frank Fontenay, Lisbeth Rischel Hilbert, FORCE Technology,  
Denmark*

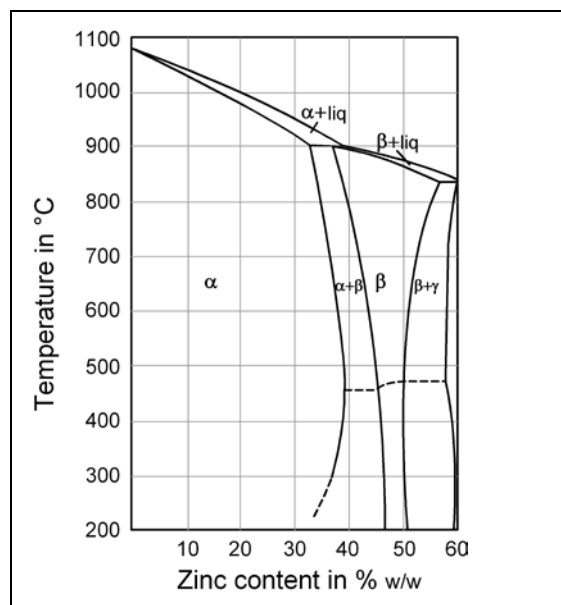
Figure 1. Copper-zinc phase-diagram

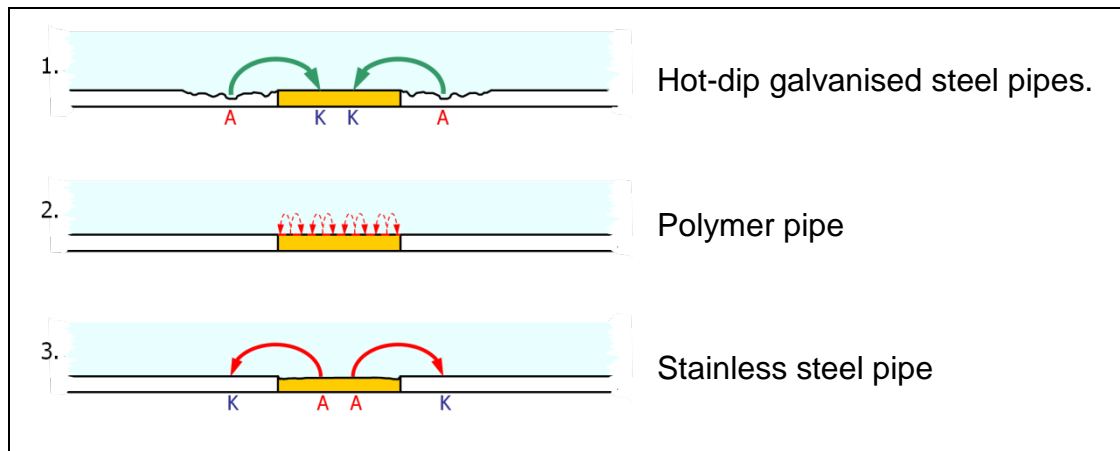
**Figure 2.** Corrosion of small brass parts in contact with different pipe materials. **1:** Small parts of brass are cathodically protected due to the contact with the less noble hot-dip galvanised steel pipes. Corrosion on the hot-dip galvanised steel pipe is enhanced due to bimetallic corrosion. **2:** Polymer pipes do not affect corrosion of the brass part. Corrosion is governed by the corrosion properties of the brass part itself. **3:** Stainless steel suitable for use in drinking water is more noble than brass. Corrosion of the brass part will be slightly enhanced due to bimetallic corrosion.

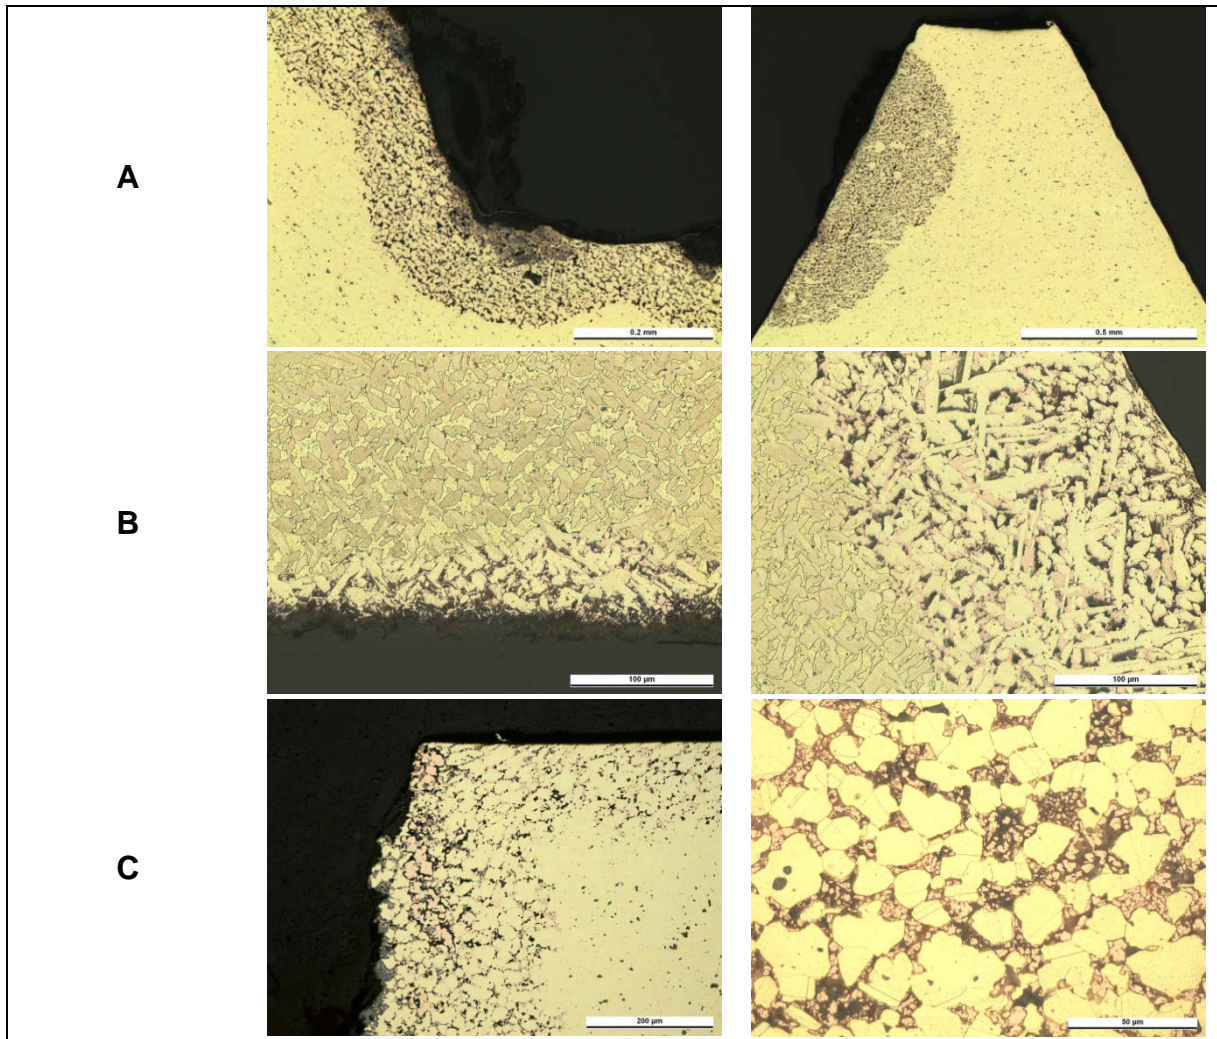
In figure 3 examples of dezincification in brass fittings from drinking water installations in the Copenhagen area are shown.

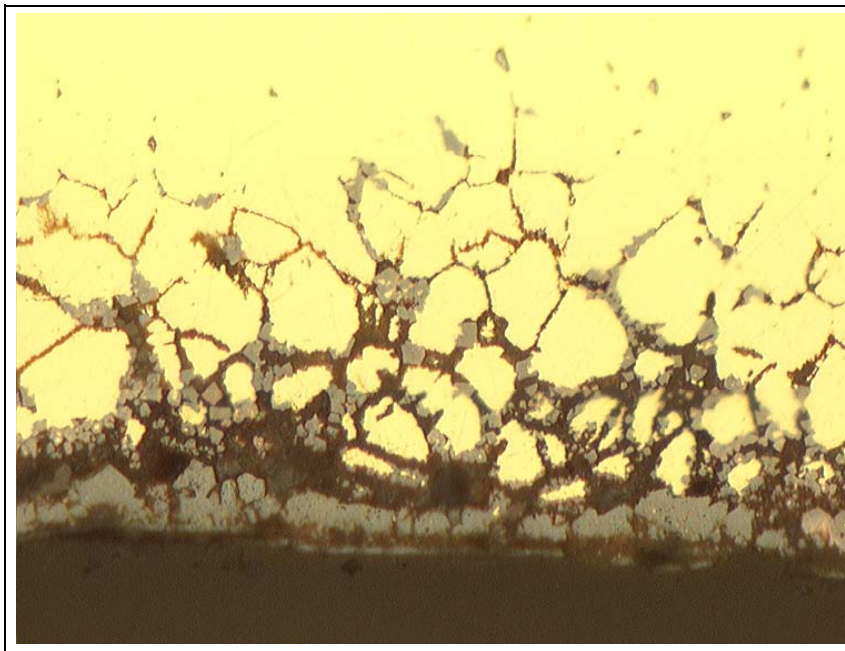
**Figure 4.** Cross section of nickel plated stop valve examined after 1 year of operation in the Copenhagen area. The valve has been assembled with a stainless steel fitting in an installation for cold drinking water.

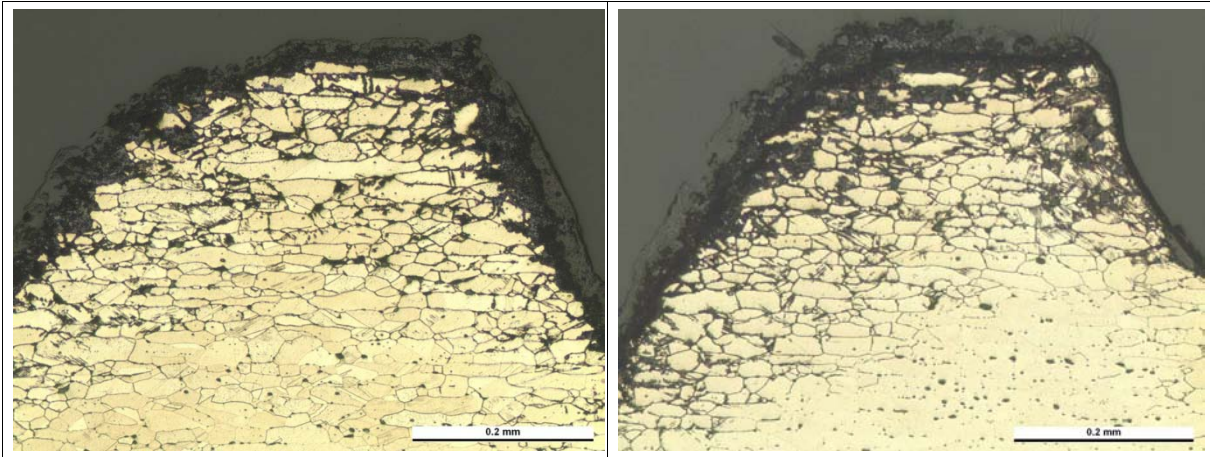
**Figure 5.** Examples of intergranular corrosion as seen in the Copenhagen area. Cross section of DN 15 nipple-muff (left) and DN15 stop valve (right) taken from the same installation after 2-3 years of operation. Both showing 200-300  $\mu\text{m}$  deep intergranular corrosion attacks. Both parts have been assembled with other brass fittings in an installation for cold drinking water.

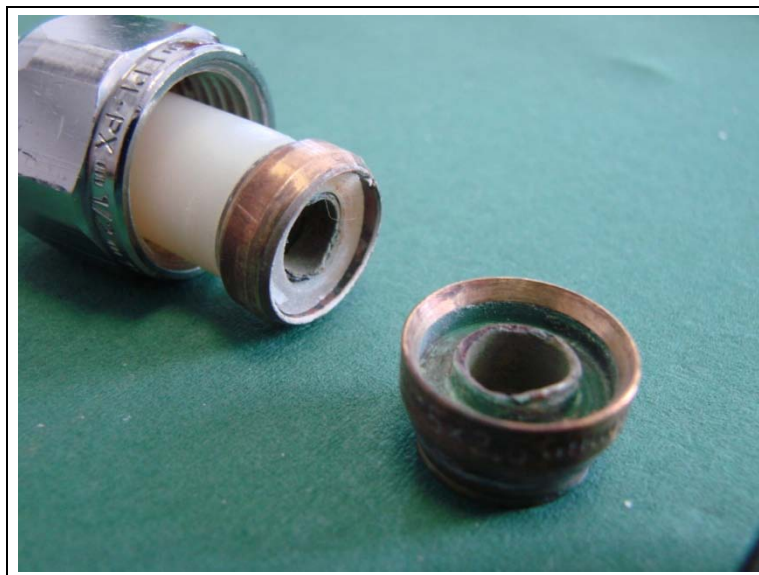
**Figure 6.** Clamp ring fitting after 5-6 years of operation. Fracture on the bushing due to intercrystalline corrosion.

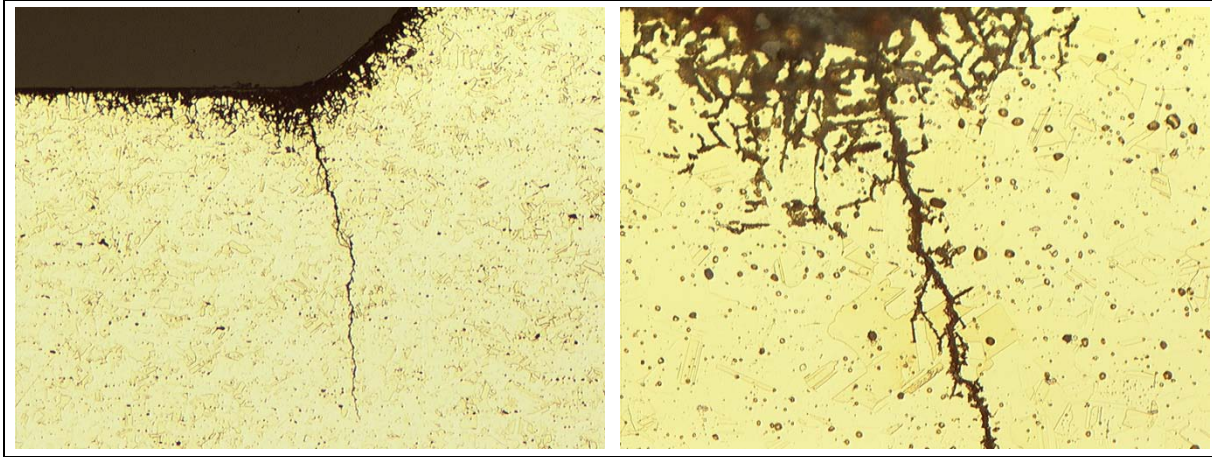
**Figure 7.** Cross section of DZR nickel plated stop valve examined after 1 year of operation in the Copenhagen area. The valve has been assembled with a stainless steel fitting in the installation for cold drinking water. Intergranular corrosion attacks from the water side in combination with high tensile stress have led to SCC.

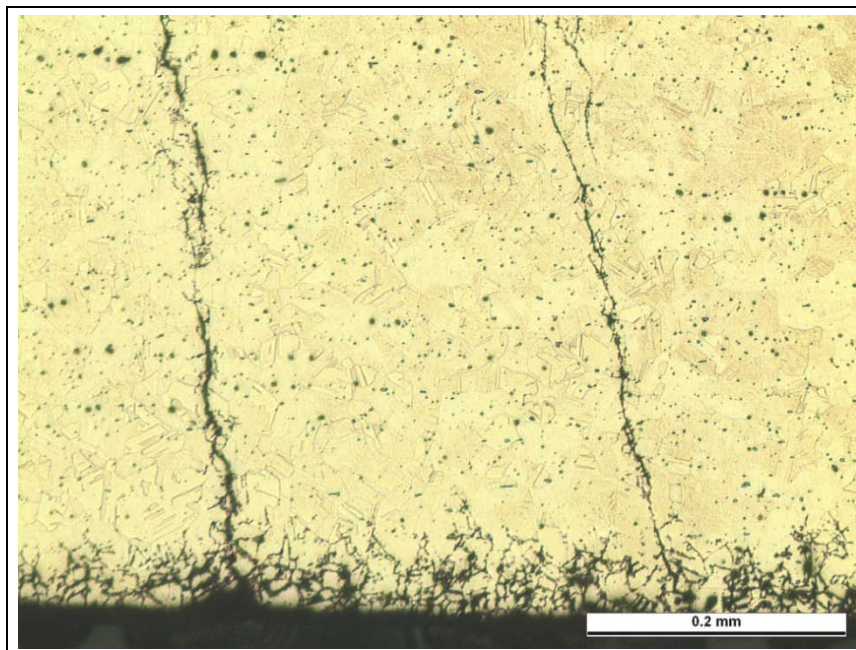
**Figure 8.** Cross section of a DZR stop valve taken from an installation for warm drinking water after 2-3 years of operation. Investigated due to failure. The cross section shows two cracks due to SCC from the water side. Intergranular corrosion attacks of app. 100  $\mu\text{m}$  are observed on the surface.

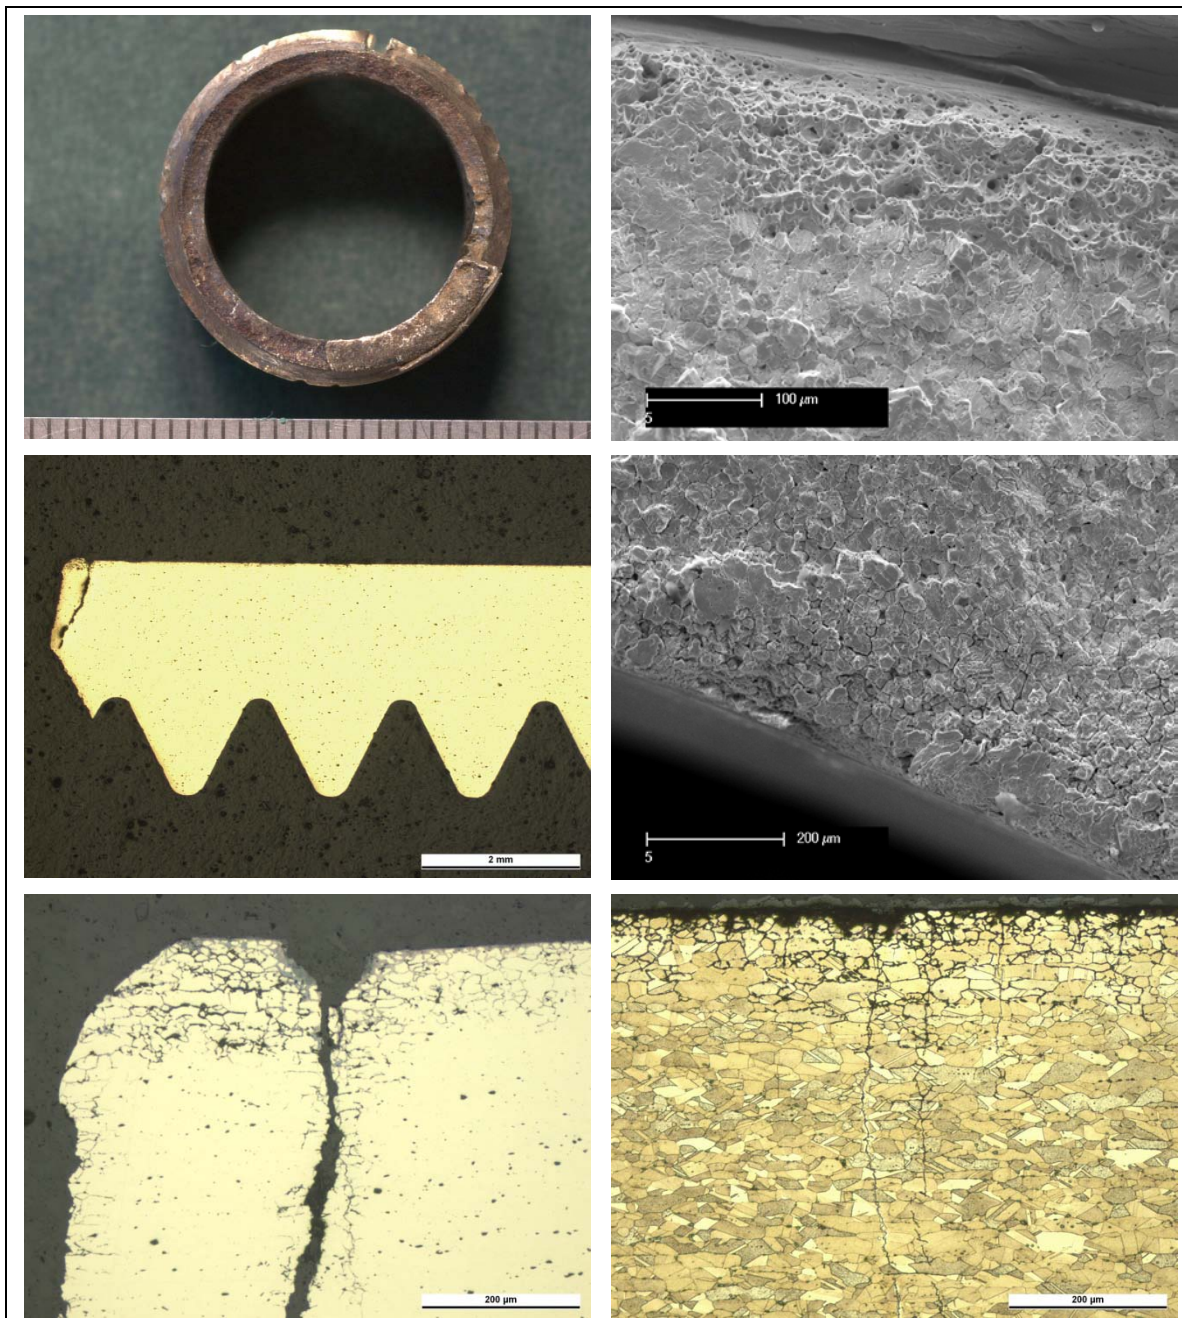
**Figure 9.** Examination of failed DN20 drain valve from a 10 year old installation with stainless steel pipes (AISI 316). **Top left:** Fracture surface, overview. No sign of plastic deformation. **Top right**
