No. 8

A newsletter from FORCE Technology on corrosion, metallurgy and chemical analysis

May 2009

The welding ghosts of the past may also appear today

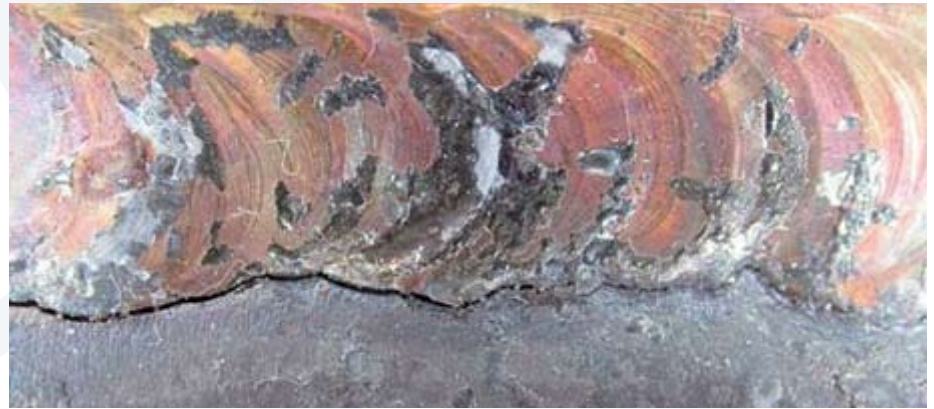
FORCE Technology was assigned to examine cracks in some welded brackets. It turned out to be hot cracks that had occurred by welding of ordinary black steel.

Figure 1: Welded brackets with cracks along the welding.

The cracks appeared during cooling of the welds, while the weld was still cherry red. The cracks ran along the edge of the weld in the base material, as shown in figure 1. There were no cracks in the actual weld metal. The cracked surfaces were quite clearly blue-tempered.

The conclusion to this case is that the crack formation is caused by 'liquation cracking' primarily due to a too low manganese/sulphur combination in the steel. The customer was recommended to apply steel with a higher manganese/sulphur ratio. Alternatively, it may be specified that the steel must pass a welding test without cracking prior to acceptance of a delivery.

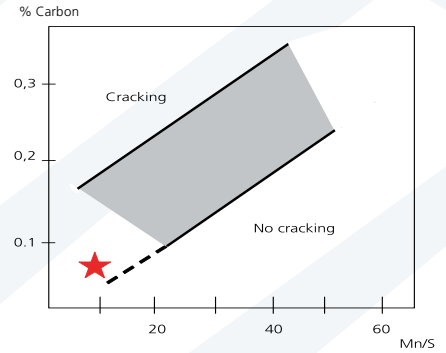
Cracking will appear in the old grain boundaries providing the crack surface with its characteristic intercrystalline look. The crack phenomenon is called hot cracking or 'liquation cracking', and it is usually dependent on the manganese/sulphur combination in relation to the carbon content, as shown in figure 5. Earlier, steel contained more carbon and to preserve good weldability, it was necessary to maintain a sufficiently high manganese/sulphur ratio to stay out of the cracking zone, cf. figure 5. The star in the figure shows the values of the examined steel. The point of data is outside the examination matrix (the grey area) but the extrapolated dot-

Figure 5: Copy of a diagram used in a previous project carried out by Welding Institute UK (TWI).

ted line implies that the material is within the area where crack formation may occur. It should be stressed that the degree of fixation and heat input during welding is of great importance when determining whether the cracking will occur, and presence of impurity elements in the steel, i.e. arsenic or tin may worsen the situation. It should also be mentioned that the arsenic and tin contents themselves may lead to temper brittleness.
