Corrosion monitoring – now in China!

How fire affects concrete

Concrete News is a newsletter on inspection and examination of concrete.

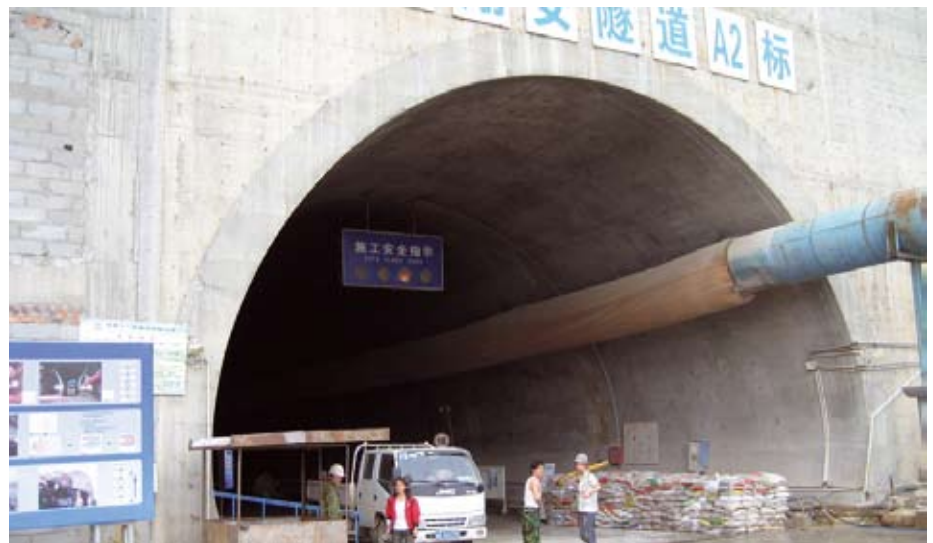
The entrance to the new Xiang'an tunnel.

As part of the development of China's infrastructure, a new tunnel, the Xiang'an tunnel, connecting Xiamen to the mainland, is under construction. The tunnel, which is 7 kilometres long with two tubes is the first subsea tunnel in China, cf. Figure 1.

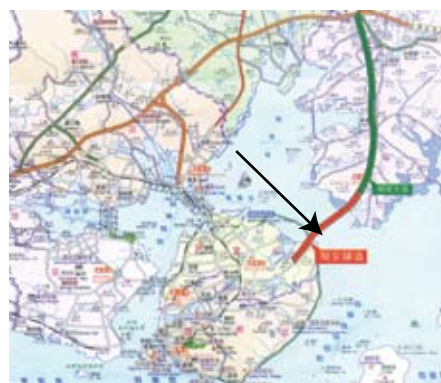
Figure 1: Illustration of how the tunnel will connect the island of Xiamen to the mainland.

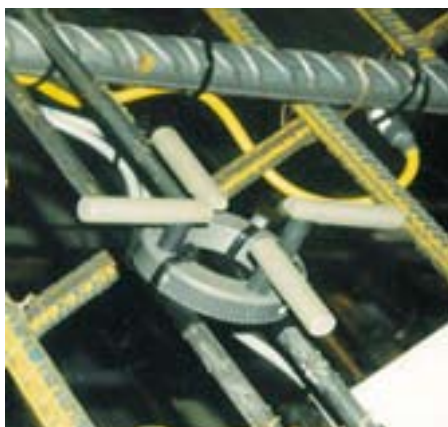
CorroWatch probe and ERE 20 reference electrode

The fully automatic corrosion monitoring system from FORCE Technology monitors corrosion activity (active/passive) – of each of the 4 anodes on the CorroWatch probes embedded in the concrete. As the CorroWatch probes are placed in the concrete cover and the 4 anodes at various depths under the concrete surface, the corrosion front may be monitored through the concrete. When active corrosion is detected in the CorroWatch probes' deepest installed anode, close to the main reinforcement, repair strategies, such as traditional repair or cathodic protection can be prepared and implemented. Corrosion monitoring thus supplies an early warning of reinforcement corrosion.

Determination of the individual anodes' corrosion activity is based on measurements of their electrochemical potentials and a 5 second macro cell current. For each CorroWatch probe, the electrochemical potential of each of the 4 anodes is measured prior to the macro cell current being determined. This is done by connecting the individual anodes on each CorroWatch, one at a time, to the Ti-mmo cathode mounted on

the probe body through a precision 0-Ohm ammeter. Exactly 5 seconds after an anode has been connected to the Ti-mmo cathode, the current running between the two is measured and the result is recorded in the corrosion monitoring system computer. The anode is then disconnected and the next anode connected and the procedure repeated after 5 seconds. This procedure is reiterated until the macro cell current for all 4 anodes in the CorroWatch probe have been determined.

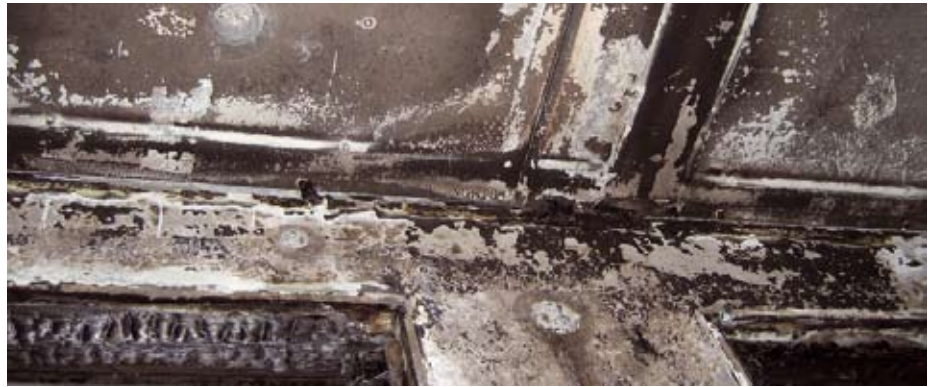
Repercussions of a massive fire impact on concrete surrounding a window opening.
