Embedded corrugated metal ducts in concrete elements need checking

Concrete News is a newsletter on inspection and examination of concrete.

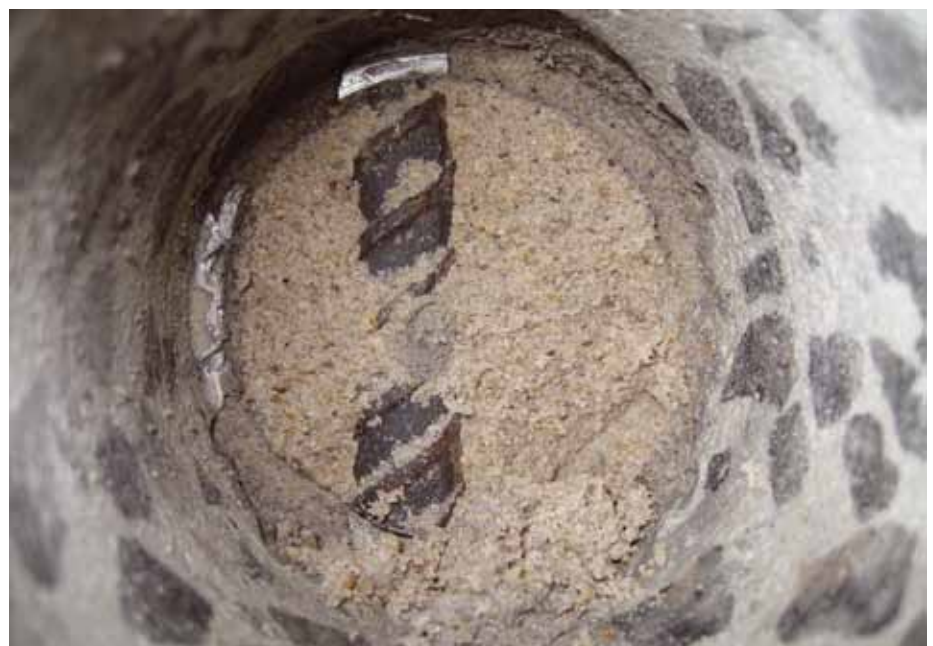
View in perimeter column showing granular material in corrugated metal duct, i.e. incoherent sand-like material.

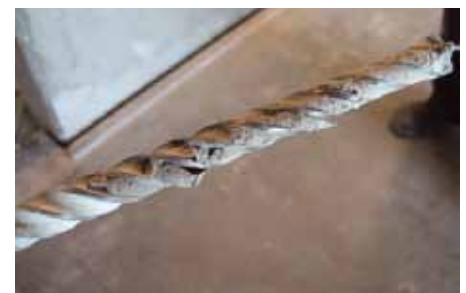
Test drilling where nondestructive measuring has localised faulty embedding. Wet/moist grouting material and not dry drill dust may be seen on the shown 12 mm drill bit.

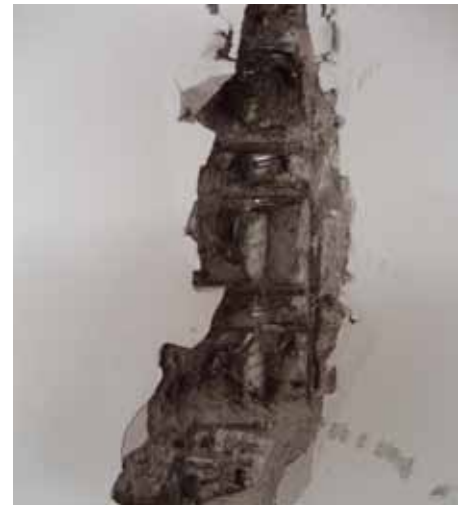
Breaking up of the wall and corrugated metal duct containing soft/wet grouting material.

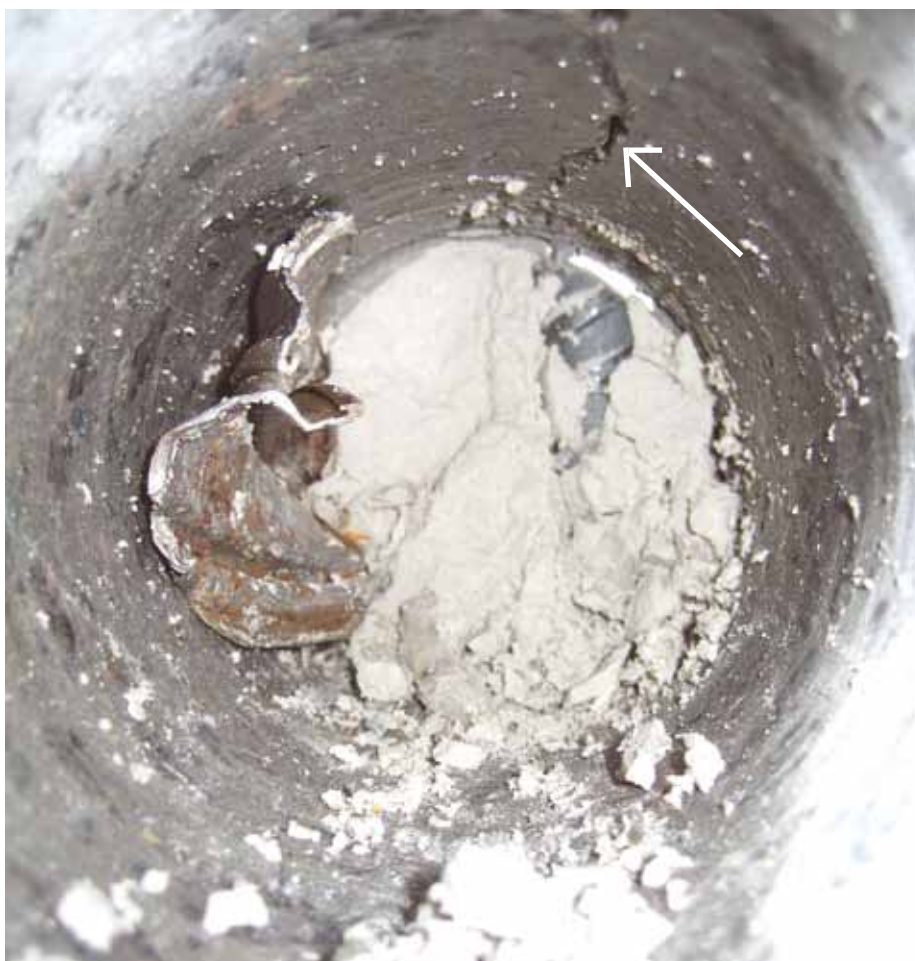
Core drilling in column showing separated material in the corrugated metal duct, i.e. cement paste. The crack is caused by frost burst in the corrugated metal duct.

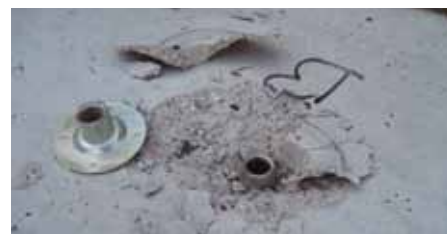
Fracture in anchor as a result of tensile testing.
