Cleaning removes rust on the façade

A report from FORCE Technology shows that the rust on the façade of the Opera can be removed and prevented through regular cleaning.

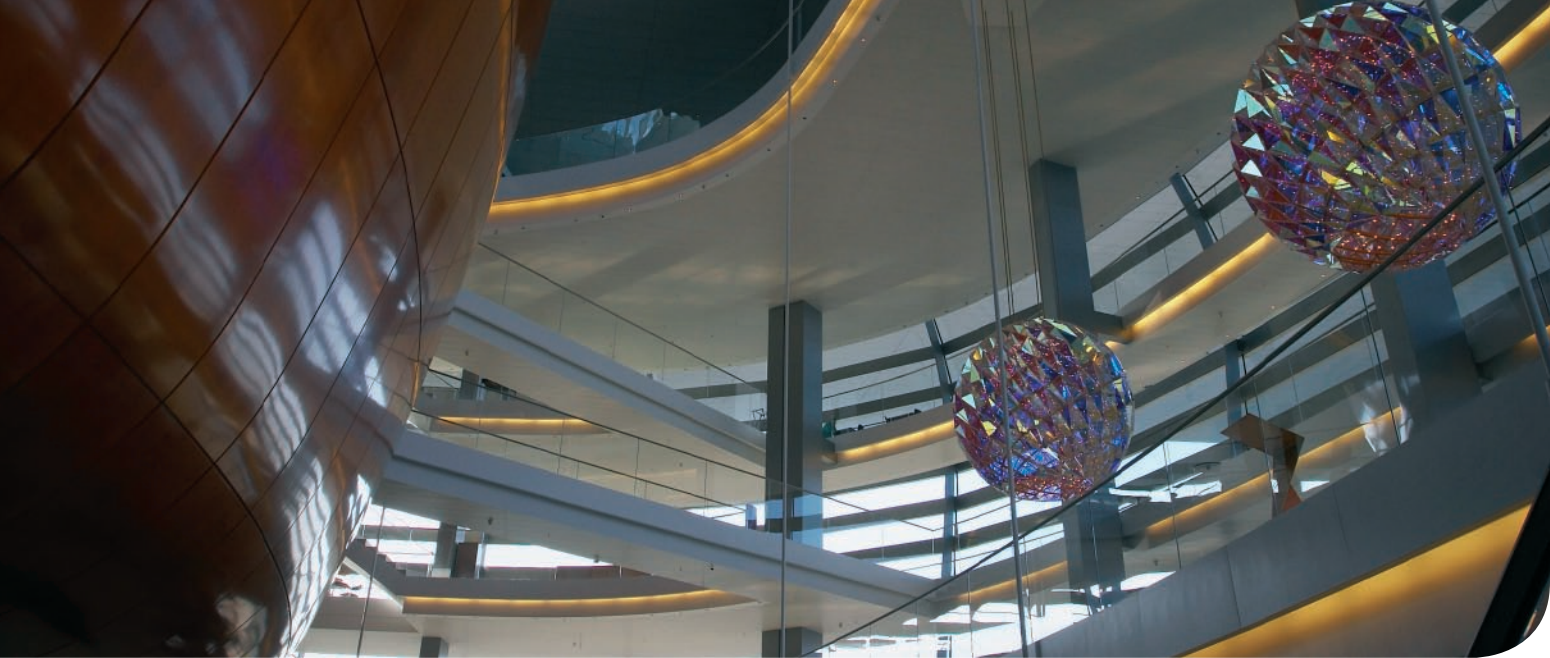
Famous Danish singers were not the only ones to take a deep breath at the Royal Danish Theatre in the late summer of 2005. Brown stains had appeared on the steel façade of the Opera and they gave rise to concern among many people outside the world of the Opera. Especially on the steel panels at the entrance of the Opera, many brown stains had appeared despite the fact that the panels were made of stainless steel.

The conclusions of the investigation have taken the heat out of the worst notions of the consequences of the brownish stains on the façade of the Opera. The investigation established that the correct materials were used. The rust mainly originates from particles that have polluted the surface of the façade.

“Most of the stains can be removed fairly easily by cleaning. Basically, the stainless steel should be cleaned every six months to look nice just as the windows need to be cleaned. This is also stated in the supplier’s operation and maintenance manual for the components in question. Regular cleaning would also prevent problems with rust stains from occurring again”, says Troels Mathiesen.
