Avoid pollution: Protection of embedded oil tanks

After the fire – what is the risk of damaged materials?

Material News is a newsletter on corrosion, metallurgy and chemical analysis.

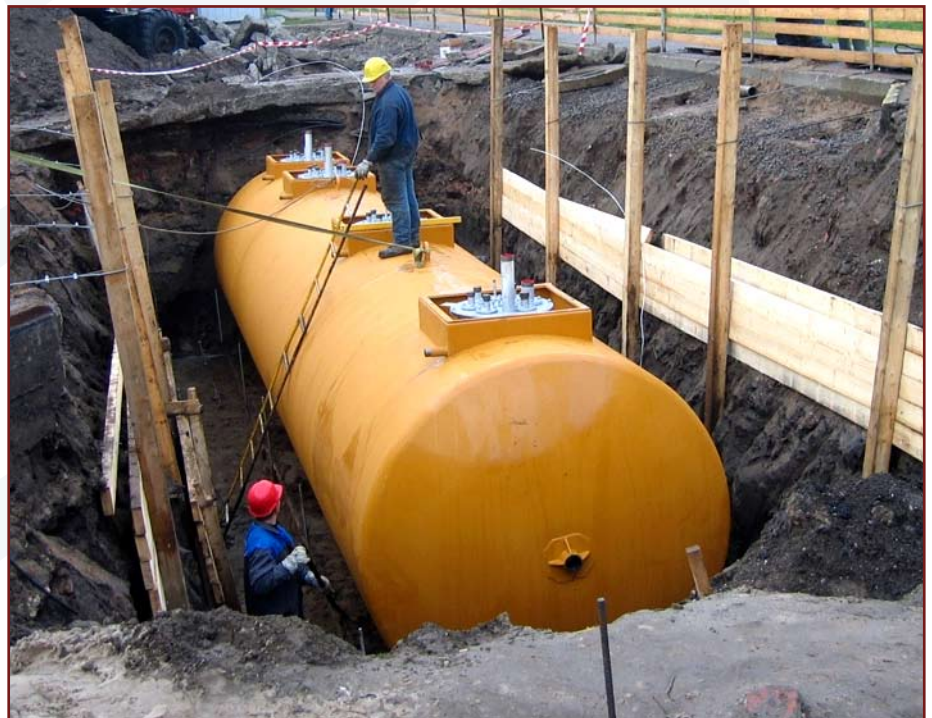
FORCE Technology assist at determining the correct surface treatment of embedded tanks to avoid corrosion.

In order to perform the correct corrosion preventive surface treatment, FORCE Technology have made a guideline that focuses specifically on embedded oil tanks. The paper describes the correct treatment of both outside and inside surfaces. It also says how the product in the tank determines the choice of paint type. If you wish to receive the instruction (no. 3101-1-en) you may contact Alice Rasmussen at telephone no. +45 43 26 74 00 (direct line) or via e-mail at ar@force.dk.

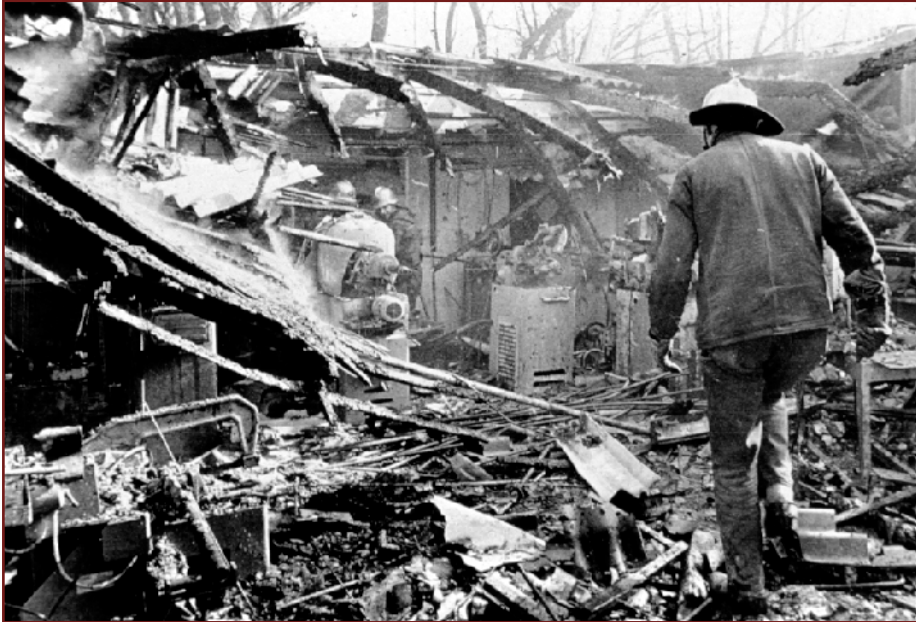
Fireplace with different workshop machinery

Fire on industrial equipment occurs now and then. The extension and strength of the fire varies from case to case, which means that the extent of smoke and heat generation varies too.

Humidity generated from the fire and use of water to extinguish also varies, but in any case: In order to answer following questions after the fire some analytical work has to be done early after the fire for planning the salvage work:

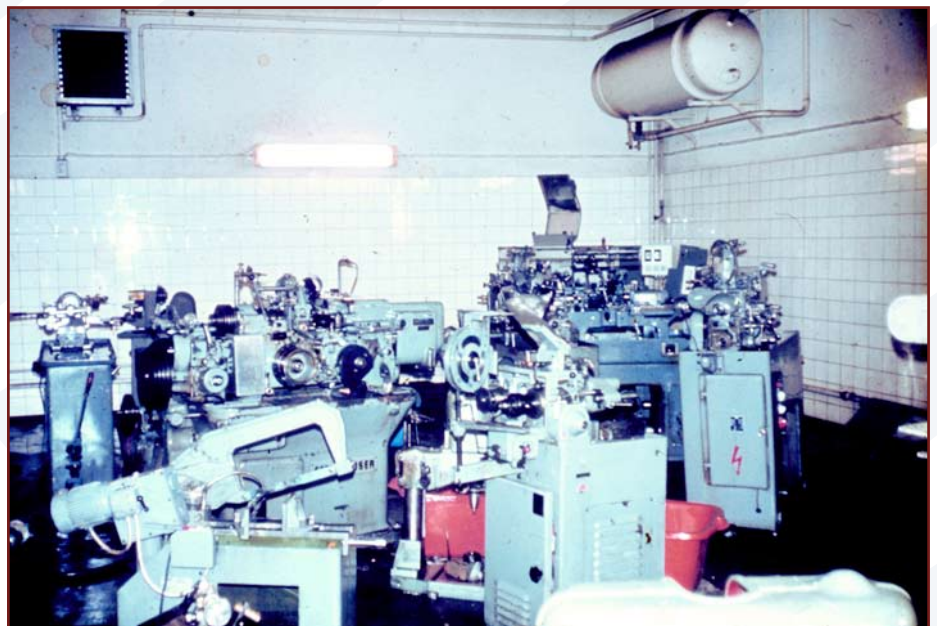
The same machinery after completed salvage work.

Metal chloride contamination of the surface alters the interaction with the surrounding air humidity. For instance, ferric chloride contamination on a steel surface results in that the surface will corrode at humidity higher than 45%RH whereas a generally contaminated surface will start to corrode above 60%RH. Thus metals with a general contamination exposed to 55%RH will not corrode. If it is contaminated with chloride during a fire it will afterwards corrode at the same humidity. This means that the conditions have changed due to the fire and a real corrosion risk exists if the chlorides are not removed.

It is thus important to know about the degree of chloride contamination level after the fire. This can be done by determination of the surface chloride concentration. Many years of research and experience has shown that a level above 8-10 $\mu\text{g}/\text{cm}^2$ indicates elevated chloride level which needs cleaning to eliminate the corrosion risk. This baseline comes from a possible background chloride level up to 8 $\mu\text{g}/\text{cm}^2$. In special places, for instance clean rooms, where the acceptable chloride level is below 5 $\mu\text{g}/\text{cm}^2$ this level has to be referred to when the action of a fire is judged.

The determination of the chlorides is made by electrochemical analysis directly on surfaces selected from the information about the spreading of the fire.

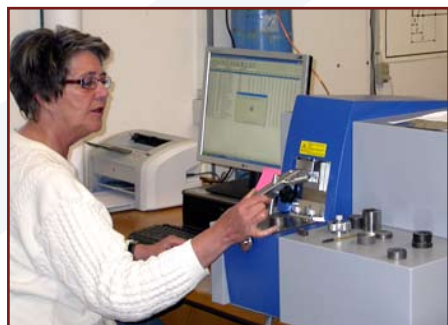
FORCE Technology in Esbjerg has recently invested in new OES-analysis equipment (Optical Emission Spectrometry). This provides the customers with the opportunity to get their stainless steel analysed in addition to the unalloyed and low alloyed steel, which have been analysed in Esbjerg so far.

The new equipment differs from the previous as it is able to determine and detect nitrogen, a quality that is more and more in demand.

nology will also be able to perform fast and complete analyses of very little items, - the so called mask analysis - e.g. on a chip taken from a pipe, a flange or the like. The size requirement on such a chip is that one should be able to flatten it or spread it out - to a diameter of minimum 6 mm.
