## Building of a new fountain - it is not always that straightforward

## Is your facing wall in danger of collapse? Corrosion of wire ties is a hidden risk

## Can inhibitors decelerate ongoing corrosion in reinforcement?

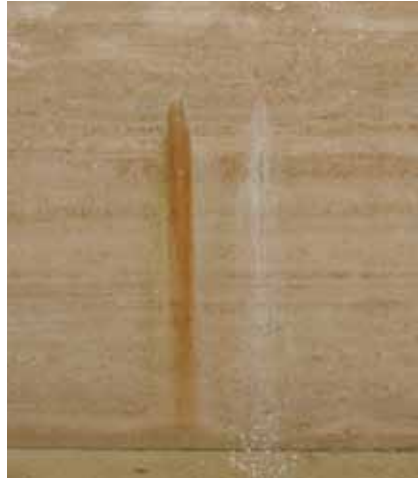
White and brown precipitations on an entirely new fountain.

The fountain was built of concrete clad by tiles on all visible surfaces. The applied Italian travertine was of the type Travertino Classico. Precipitations had now been found both through and over the travertine. The precipitations had started immediately after water filling and developed into first whitish and later brownish precipitations after about three weeks.

Precipitations were found on by and large all tiles; typically locally around cracks and areas with increased porosity. The precipitations were typically whitish, but locally they appeared with a brownish colour. Also, increased growth of alga was seen on and along these precipitations, which had a granular character and could easily be scraped off.

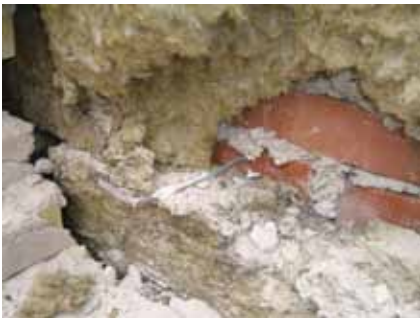
Housing association Fjordblink. Almost intact tie can be seen. Photo courtesy of Grontmij A/S in Aalborg.

A typical example of this variation of corrosion attack can be seen in examinations performed for Grontmij A/S in Aalborg for the housing association Fjordblink Dept. 13 in Aalborg. See photos. The housing estate was built around 1966, and both corroded and almost intact hot-dip galvanized ties were found in the same block. Therefore it was decided to renovate this housing estate.

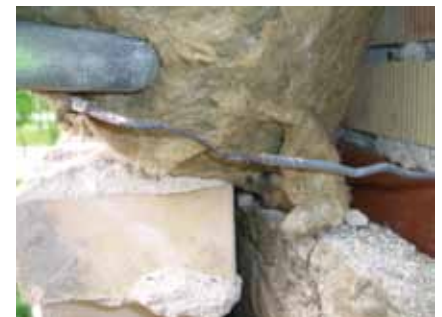
Housing association Fjordblink. Galvanized tie is almost corroded through. Photo courtesy of Grontmij A/S in Aalborg.

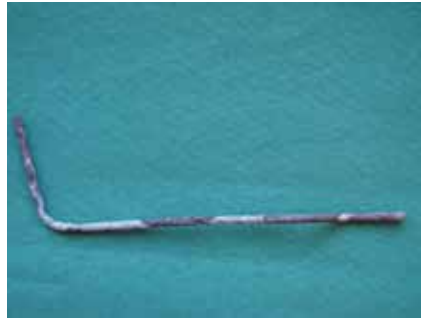
Example of wire tie of hot-dip galvanized steel after about 30 years. Very deep corrosion attacks at bend and in straight piece.

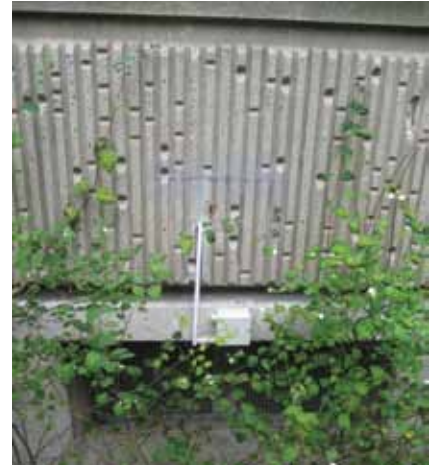
Measuring of corrosion rate with and without applied inhibitors

Field measuring is supplemented by laboratory examinations of fifteen samples exposed to carbonisation under accelerated conditions. The samples have been divided into three groups; inhibitor treat-

ment, treatment with inhibitor with colour washing and untreated reference surfaces. Measuring of laboratory samples is performed by using the same electrochemical techniques as in the field examinations; however the LPR technique, a well-known method of measuring the corrosion rate, is also used.
