Inspection for hydrogen damages

Procedure for Automated Ultrasonic Examination of areas with hydrogen damages

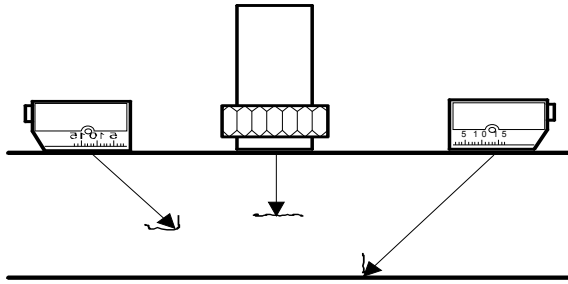
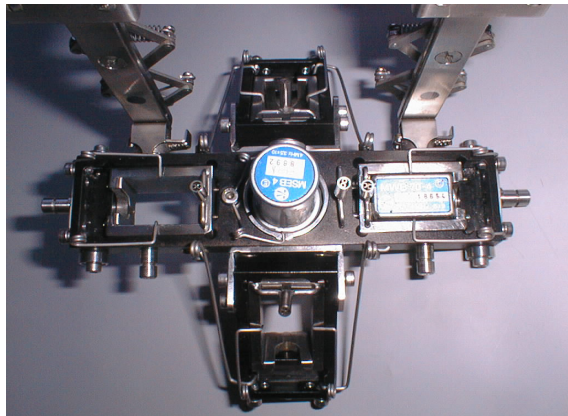
The application of automated ultrasonic examination for the detection of cracking and surveillance of defects during consecutive examinations is advantageous. The examination may be performed with the P-scan system with straight beam and angle probes in one single scanning and all echoes down to noise level are recorded.

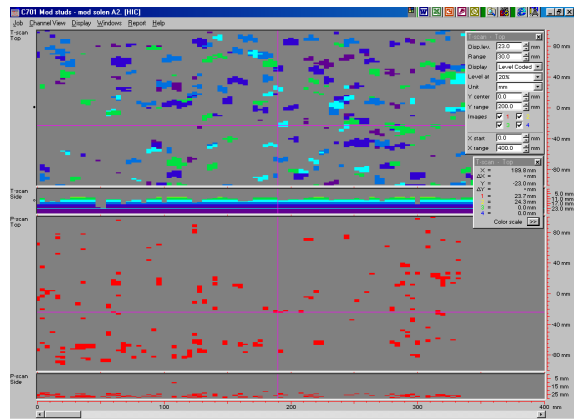
The picture below shows the result of an automated ultrasonic examination. In the upper large part of the picture, the laminar indications are imaged with a color scale (blue – green), which image depth positions as shown in the small image below. In this case, severe extent of laminar indications is observed. In the lower large part of the picture, the 'vertical' indications are imaged in one color (red) showing the area distribution. In the lower small image the position in depth is shown. In this case, severe extent of 'vertical' indications is observed.

Result of examination with straight beam probe (gate with reflections from defects) shown in the upper views (T-scan) and the results of examination with angle probes (P-scan) in the lower views

An example of automated ultrasonic examination of an area with damages at inner third of the shell (thickness 25 mm)

Based on the acceptance criteria, which includes amplitude and position evaluation, FORCE Technology has recommended planning of the repair work, which must be performed during the first shut down.
